## Inspection of Pipe Welds Using the Radiography Method with the Double Wall Double Image Technique

**Aulia Riska, \*Syukran, Hasrin Lubis**  
Politeknik Negeri Lhokseumawe  
Lhokseumawe, 24301, Indonesia  
*\*Corresponding author:* [syukran@pnl.ac.id](mailto:syukran@pnl.ac.id)

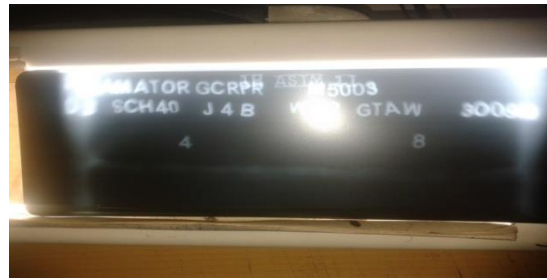
Fig 6. Film result

Based on the Fig 6, it can be seen that in the top position of the rear weld there is significant undercutting so that it needs repair or re-welding and is declared rejected by the interpreter. As shown in Fig. 7.
