## Analysis Of Helical Gear Failure In Off-Road 4×4 Gearbox

### Abstract

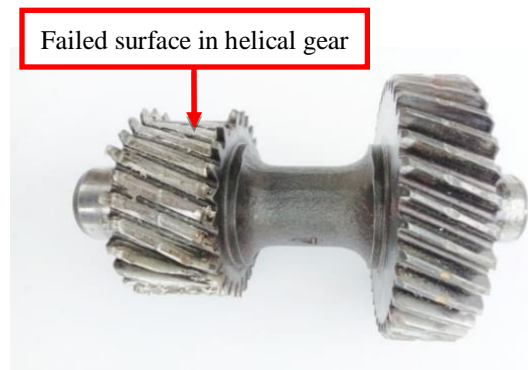
Helical gear was crafted from high-carbon steel, in accordance with AISI 1080 standards [12]. Fig. 1 showed the helical gear failure, which indicated surface damage.

Fig. 1. Helical gear failure.

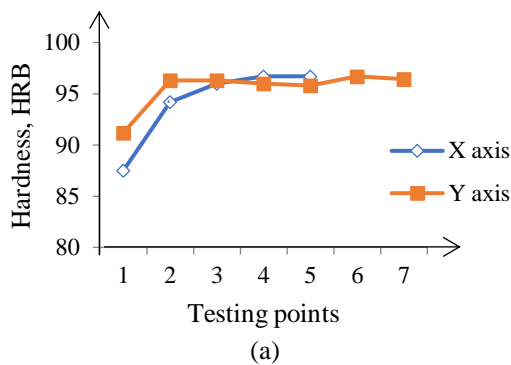
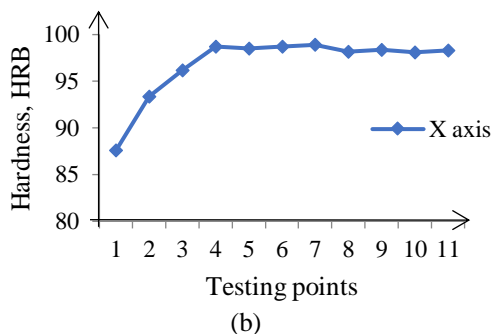
Hardness testing showed varying values near the outer and middle parts of gear surface, as presented in Fig. 6. The X-axis represented hardness in the vertical direction, and the Y-axis represented hardness in the horizontal direction as shown in Fig. 2.

Fig. 6. Hardness testing results graph, (a) outer part, (b) side part.

The average hardness value from the test was 95.49 HRB, lower than AISI 1080's average hardness value of 99 HRB.

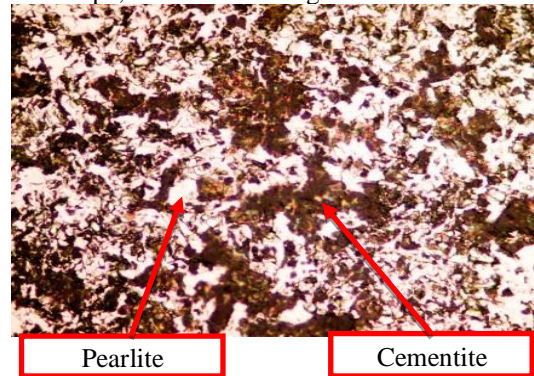
Fig. 7. Microstructure observation results at 500x magnification with pearlite and cementite microstructure.

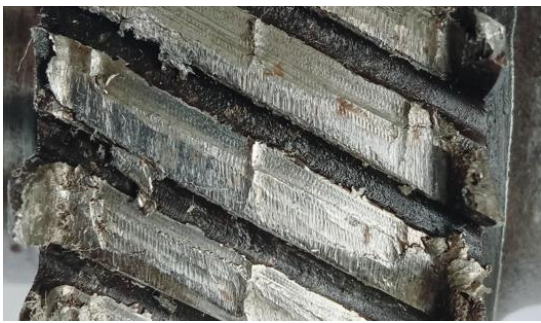
Visual observation showed that damage spanned more than half of the total gear profile. The fractured surface of the damaged gear was presented in Fig. 8, showing a brittle fracture pattern characterized by a granular appearance, light reflection, and occurrence in materials with a high carbon composition.

Fig. 8. Fractured surface due to failure.

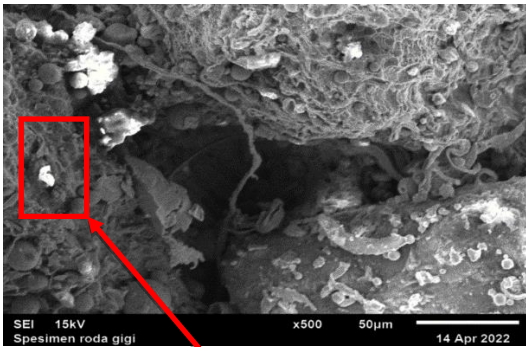
SEM observation results, shown in Fig. 9, further described characteristics of brittle fracture, denoting a granular, shiny surface reflecting light, commonly found in materials with a high carbon composition.

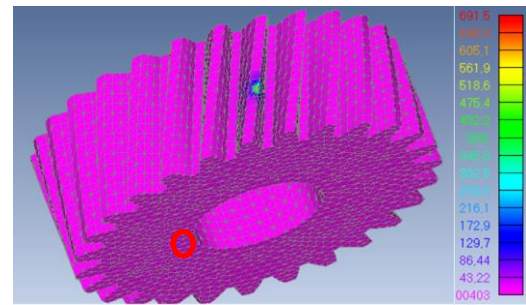
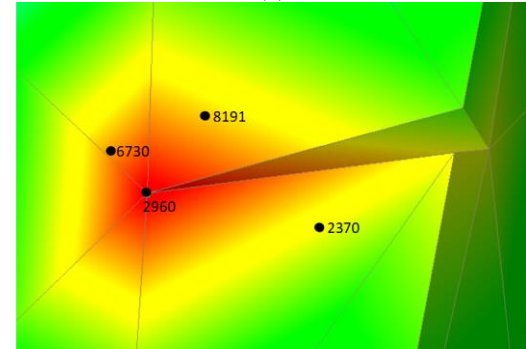
Stress analysis with initial crack signified that the minimum von Mises stress was 43.22 MPa, while the maximum von Mises stress reached 691.5 MPa, as shown in Fig. 10(a).

Stress intensity factor analysis ( $K_I$ ) on helical gear with initial crack yielded average value of 54.65 MPa.m<sup>1/2</sup>. Since fracture toughness value ( $K_{IC}$ ) for AISI 1080 material was 45.5 MPa.m<sup>1/2</sup>[15], it showed that crack propagated from initial crack to the final fracture, led to helical gear failure[16].

Fig. 10. (a) Simulation results with initial crack, (b) location of nodes points for stress intensity factor analysis.
