## Vibration analysis for failure detection in clean water distribution pumps: A case study in an oil and gas training center

Hernawan Novianto\*, Sujono

Refinery Mechanical Engineering, Politeknik Energi dan Mineral Akamigas, Cepu 58315, Indonesia

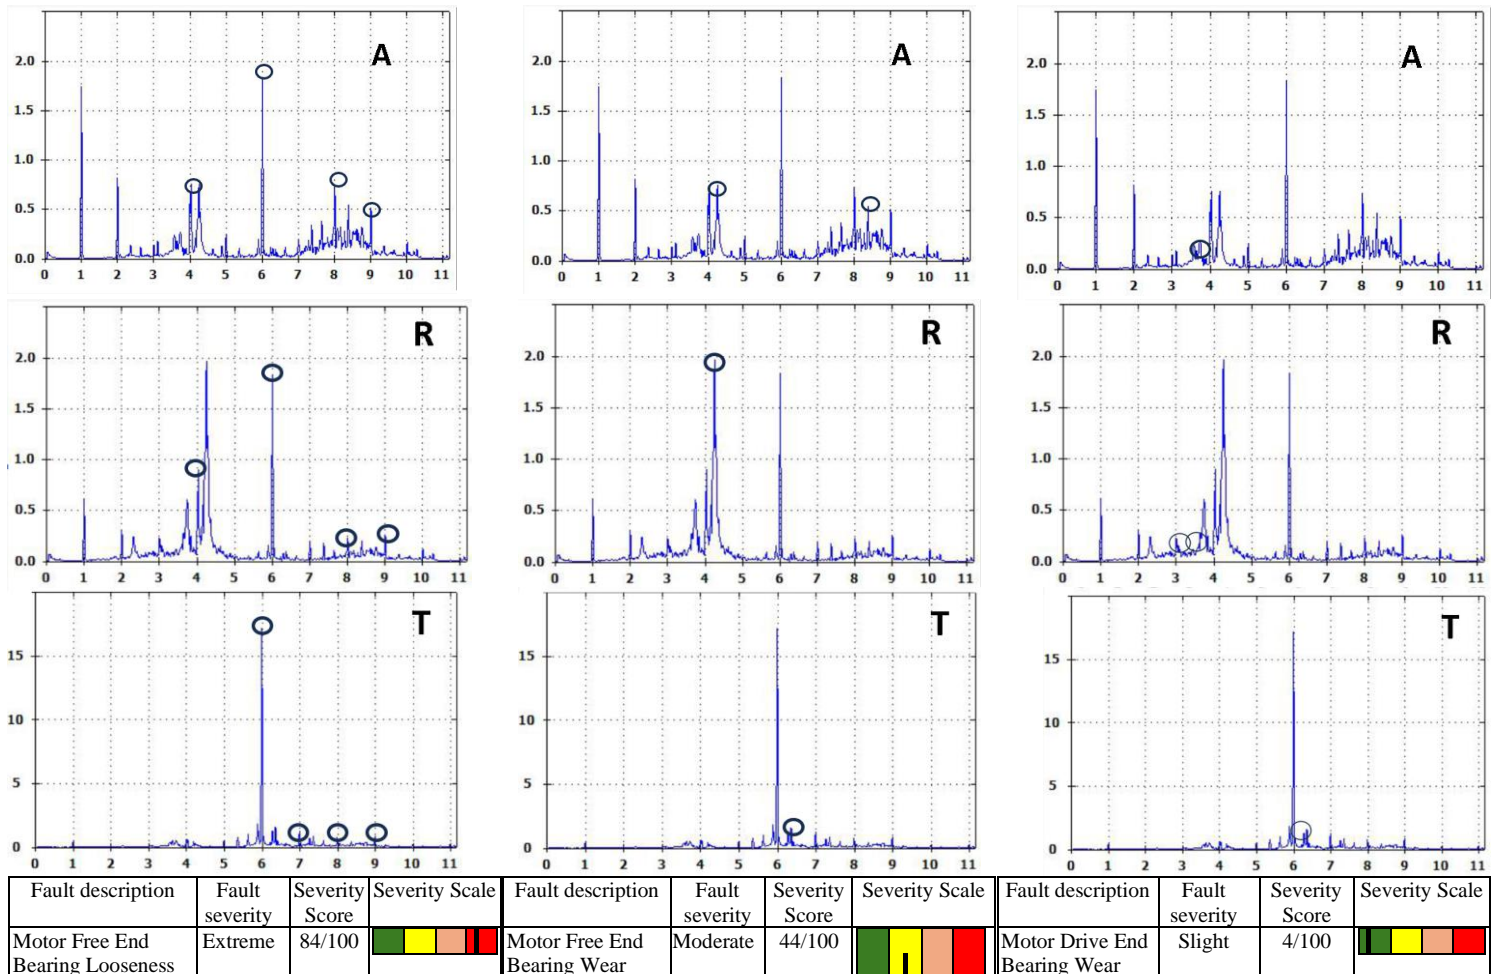
Fig. 4. Vibration monitoring and analysis in August

(a) Motor free end bearing looseness spectrum (b) Spectrum of Motor Free End Bearing Wear (c) Spectrum of Motor Drive End Bearing Wear

Specifically, at Location 1, the vibration spectrum in the axial, radial, and tangential directions indicates severe bearing looseness. This is illustrated in Fig. 4(a), where the X-axis represents amplitude (order) and the Y-axis represents frequency (mm/sec). The severity score for this condition is 84 out of 100.

At Location 1, Moderate bearing wear also occurred as shown in Fig. 4(b) (The X axis shows Amplitude (order) and Y axis shows Frequency (mm/sec)), with a severity score of 44/100. At location 2, Slight Bearing wear is indicated as shown in Fig. 4(c) The X axis shows Amplitude (order) and the Y axis shows Frequency (mm/sec)), with a severity score of 4/100.

The conclusions drawn from the vibration monitoring conducted in August indicate that the pump distribution exhibited Extreme Motor Free End Bearing Looseness, with a severity score

of 84/100. Additionally, Moderate Motor Free End Bearing Wear was observed, with a severity score of 44/100, and Slight Motor Drive End Bearing Wear, with a severity score of 4/100 (Fig. 4).

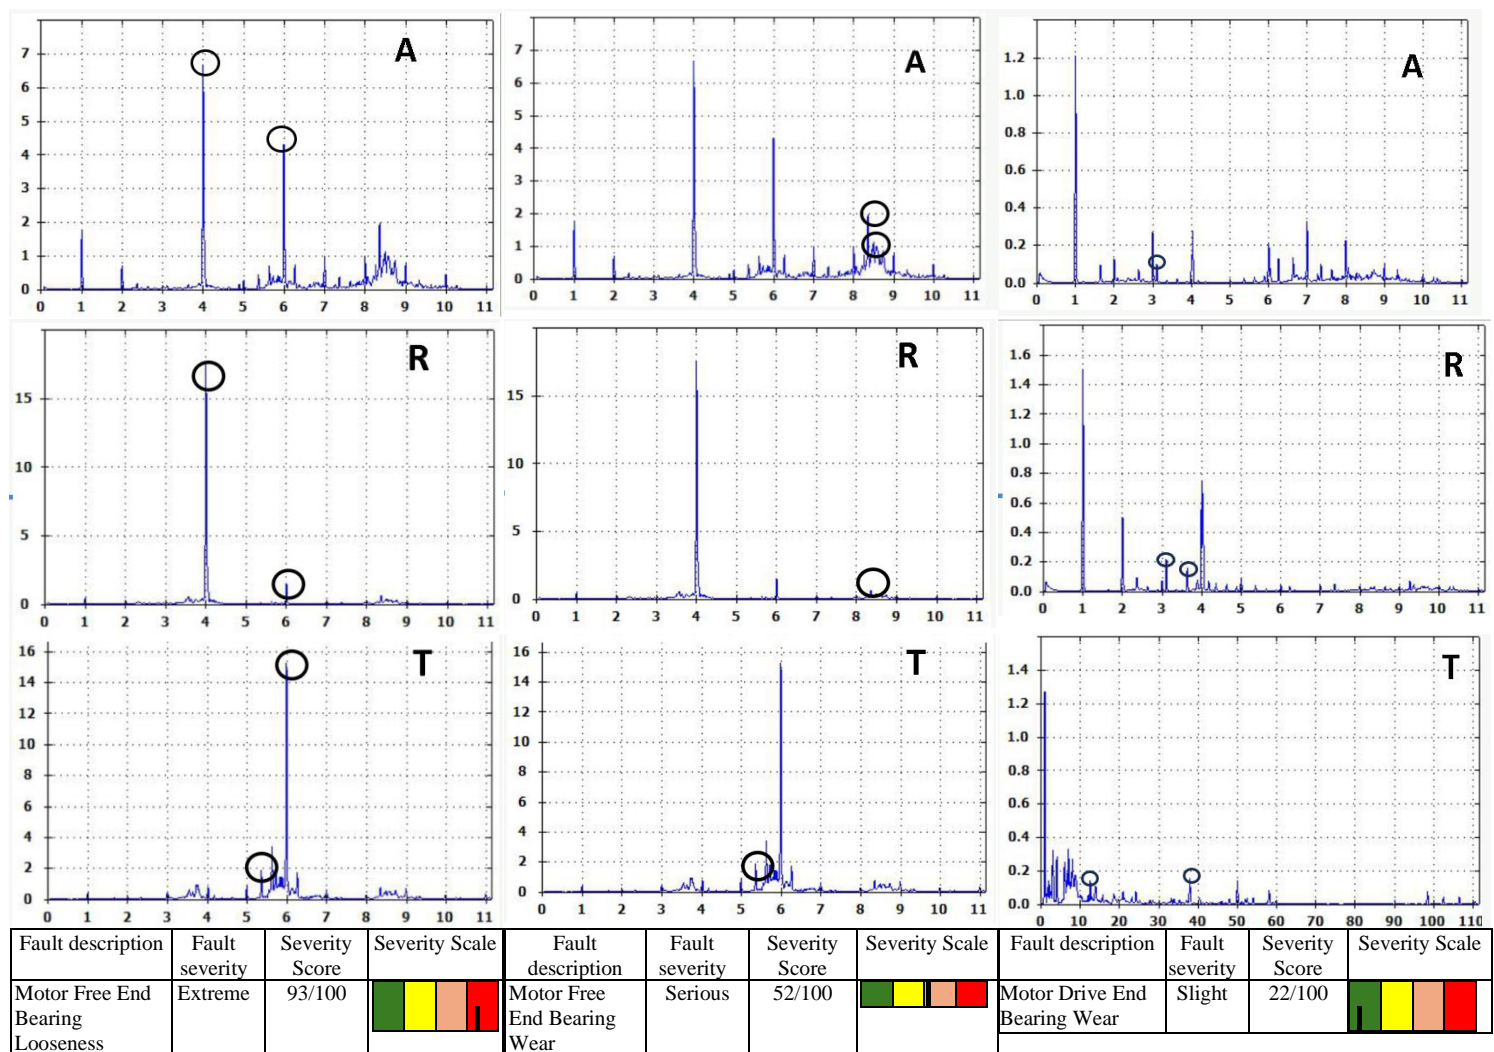
Based on multiple sample measurements conducted in October, it can be concluded that the clean water distribution pump is likely damaged. Notably, at location 1, the vibration spectrum in the axial, radial, and tangential directions indicates significant bearing looseness, as illustrated in Fig. 5(a) (where the X-axis represents Amplitude (order) and the Y-axis represents Frequency (mm/sec)). This condition has been assessed with a severity score of 93/100.

(a) Spectrum of Motor Free End Bearing Looseness (b) Motor Free End Bearing Wear Spectrum (c) Spectrum of Motor Drive End Bearing Wear  
Fig. 5. Vibration monitoring and analysis in October

At Location 1, Serious bearing wear also occurred as shown in Fig. 5 (b) (The X-axis shows Amplitude (order) and the Y-axis shows Frequency (mm/sec)), with a severity score of 52/100. At location 2, Slight Bearing wear is indicated as shown in Fig. 5(c) (The X-axis shows Amplitude (order) and the Y-axis shows Frequency (mm/sec)), with a severity score of 22/100.

The conclusions from vibration monitoring in October were that the pump distribution indicated Extreme Motor Free End Bearing Looseness, with a severity score of 93/100, serious motor free end bearing wear, with a severity score of 52/100, and Slight Motor Drive End Bearing Wear, with a severity score of 22/100 (Fig. 5).

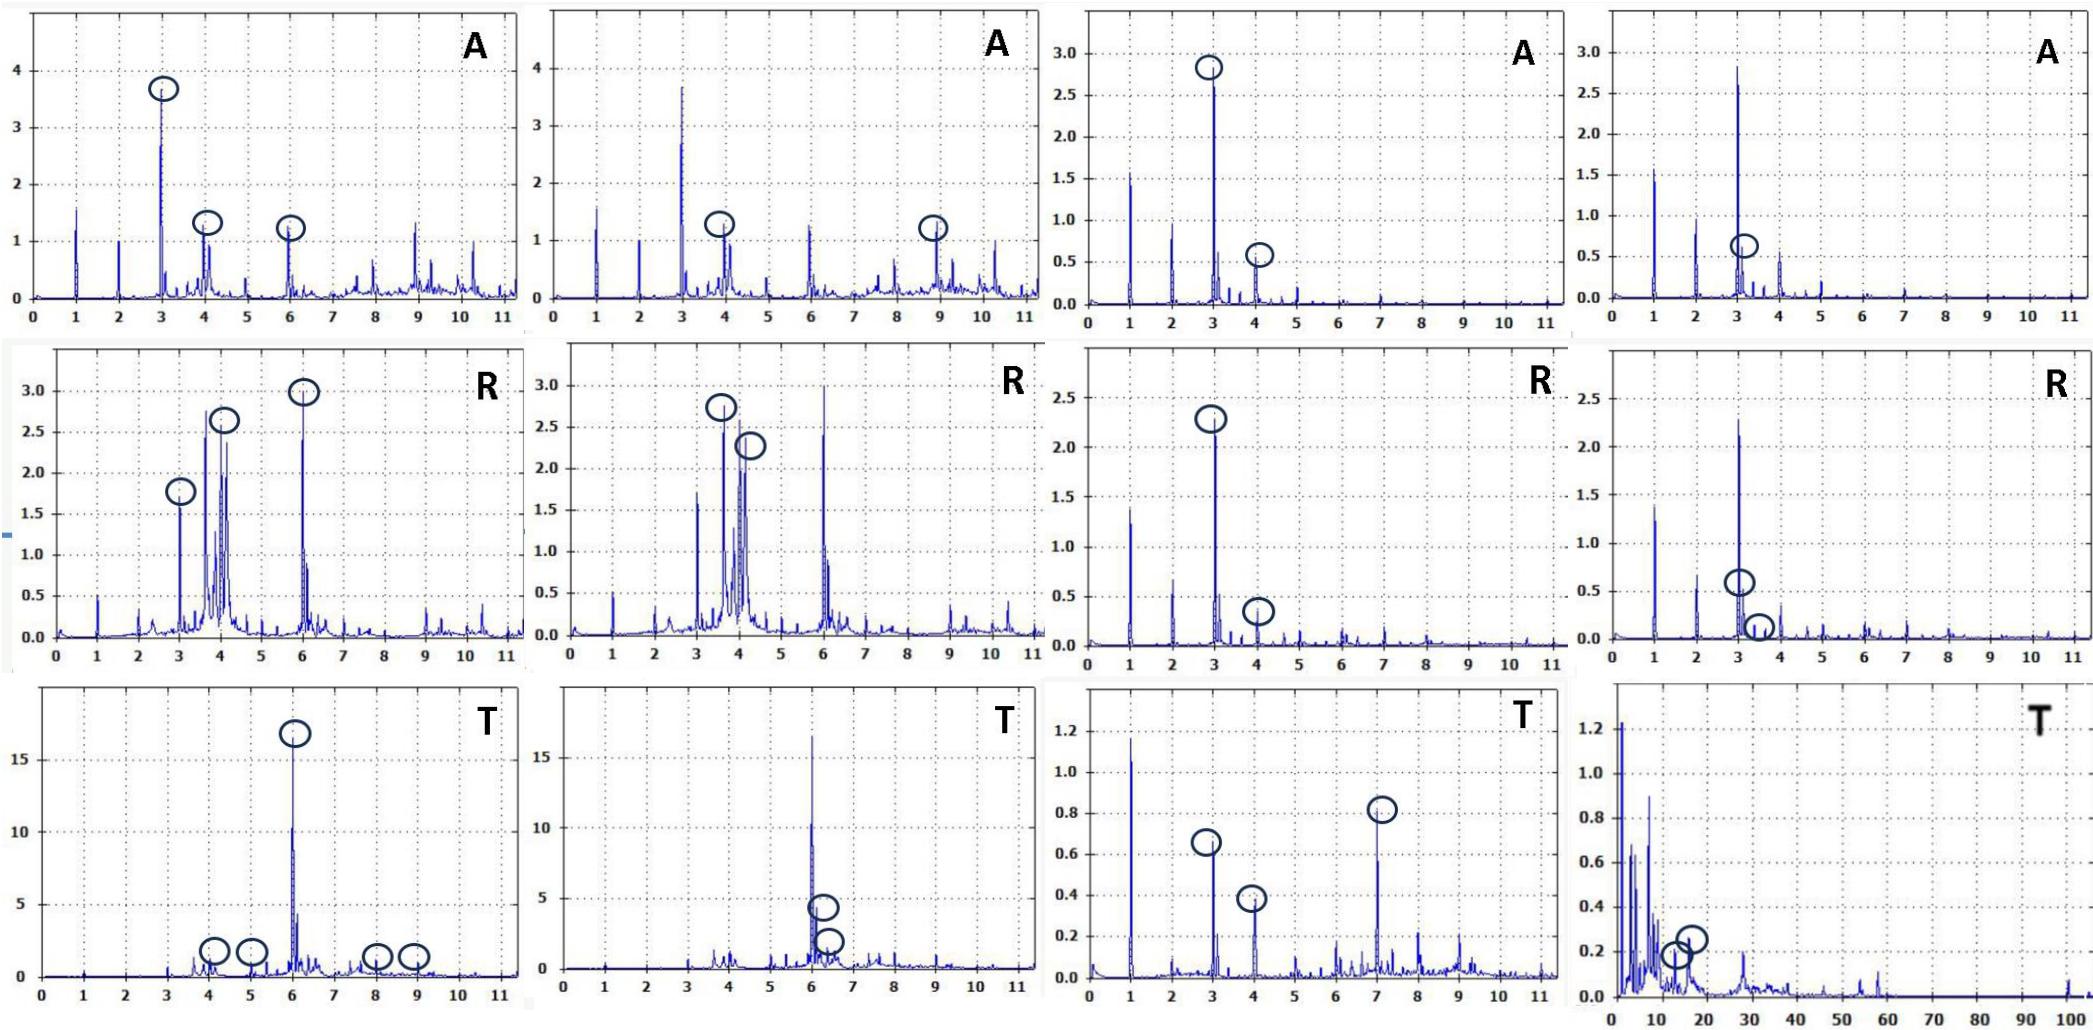
Fig. 6. Vibration monitoring and analysis in December

At location 1, the vibration spectrum, analyzed in axial, radial, and tangential directions, reveals significant bearing looseness, as illustrated in Fig. 6(a). It shows the X-axis represents Amplitude (in orders) and the Y-axis represents Frequency (in mm/sec). The severity score for this condition is 93 out of 100.

Fault description	Fault severity	Severity Score	Severity Scale
Motor Free End Bearing Looseness	Extreme	99/100

Fault description	Fault severity	Severity Score	Severity Scale
Motor Free End Bearing Wear	Serious	72/100

Fault description	Fault severity	Severity Score	Severity Scale
Motor Drive End Bearing Looseness	Serious	53/100	
Motor Drive End Bearing Wear	Moderate	37/100

(a) Motor Free End Bearing Looseness Spectrum

(b) Spectrum of Motor Free End Bearing Wear

(c) Spectrum of Motor Drive End Bearing Looseness

(d) Spectrum of Motor Drive End Bearing Wear

At Location 1, serious bearing wear also occurred as shown in Fig. 6(b) (the X axis shows Amplitude (order) and Y axis shows Frequency (mm/sec)), with a severity score of 72/100. At location 2, serious bearing looseness is indicated as shown in Fig. 6(c) (the X axis shows amplitude (order) and the Y axis shows frequency (mm/sec)), with a severity score of 53/100. At location 2, Moderate Bearing wear is also indicated as shown in Fig. 6(d) (the X axis shows Amplitude (order) and Y axis shows Frequency (mm/sec)), with a severity score of 37/100.

The conclusions drawn from the vibration monitoring conducted in December indicate several critical issues with the pump distribution. Specifically, there was extreme motor free end bearing looseness, which received a severity score of 99/100. Additionally, serious wear was observed in the motor free end bearing, with a severity score of 72/100, and moderate wear in the motor drive end bearing, which garnered a severity score of 37/100. Furthermore, serious looseness was detected in the motor drive end bearing, assigned a severity score of 53/100. (Fig. 6)

Based on the research results, it can be concluded that the clean water distribution pumps used in oil and gas training exhibit several critical issues. Specifically, there is extreme looseness in the motor free end bearing, which has a severity score of 99/100. Additionally, there is serious wear in the motor free end bearing with a severity score of 72/100, serious looseness in the motor drive end bearing with a severity score of 53/100, and moderate wear in the motor drive end bearing with a severity score of 37/100. According to the ISO 10816-3 standard, it is recommended that the motor free end bearing be replaced due to the potential for vibration to cause further damage. For the motor drive end bearing, it is advised to operate the equipment only for a limited duration.

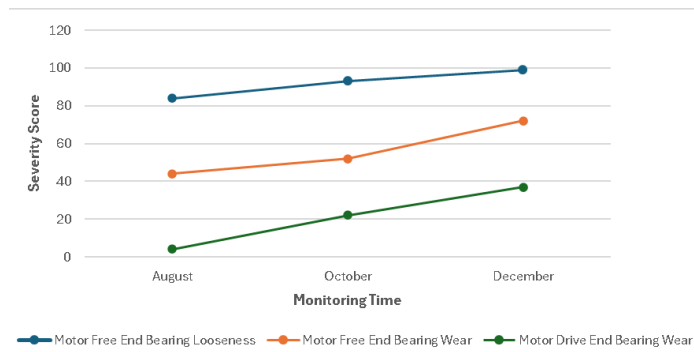
Fig. 7. Fault Rate

Summary of monitoring carried out from month October until December 2023. The results obtained are as in Table 2. while the level of damage is shown in Fig. 7. The level of damage is getting bigger. This is indicated by a graph of damage that is climbing upwards
