Detection and root cause analysis of minor tread defects in tire manufacturing using optical laser profilometry and fault tree analysis

Arwan Suwandoyo, Daisman Purnomo Bayyu Aji*

Department of Mechanical Engineering, University of Trisakti,
Jakarta 11440, Indonesia

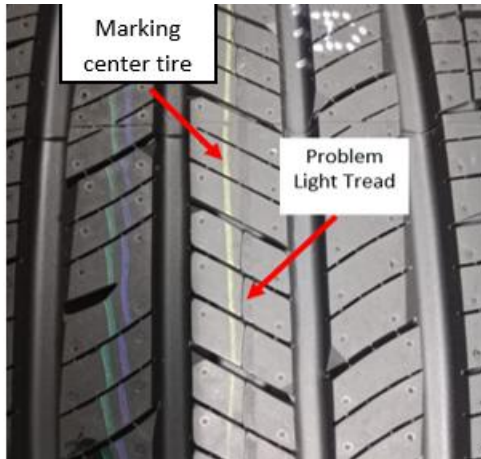
During the tire production process, a defect known as light tread may occur in the tread area. The tread is a critical component that maintains traction, stability, and vehicle safety during operation. Fig. 1 illustrates an example of a light tread defect occurring at the center position of a tire.

Fig. 1. Light tread problem on tires.

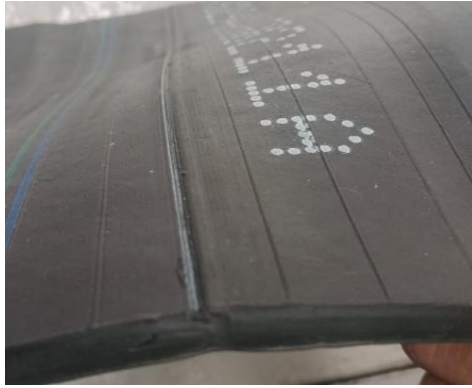
Material process: tread manufacturing process. Material inspection was performed using two methods: (1) visual inspection of the tread showed no detectable abnormalities (Fig. 3); (2) Using a non-contact optical laser profilometer, a depression was identified near the center point along the reference line.

Fig. 3. Visual inspection of tread material.

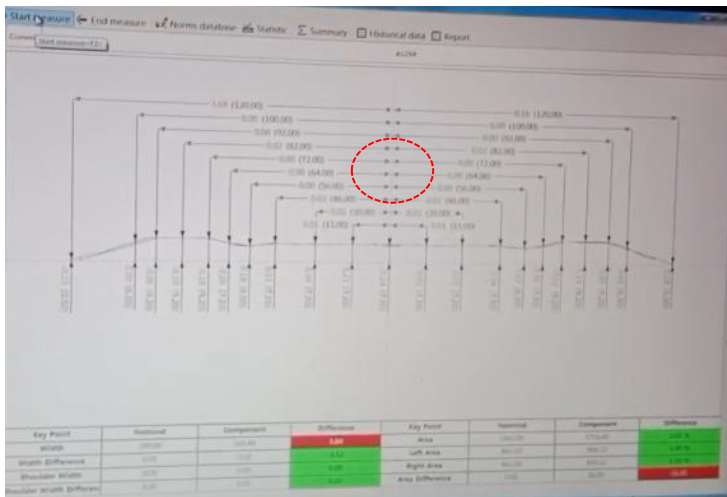
The acquired measurement data were subsequently displayed on the monitor screen, as shown in Fig. 7. The visual output in Fig. 7 reveals geometric irregularities, indicating misalignment or dimensional deviations relative to the specified design geometry.

Fig. 7. Tread scanning results displayed on the computer monitor.

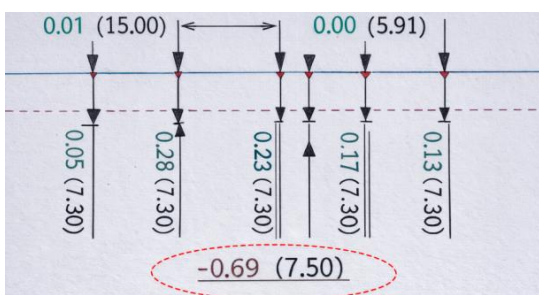
The measurement results shown in Fig. 8 were then analyzed using the dimension-addition function in the profilometer menu. These results are detailed in Fig. 8, the center tread section (in the defect area). The analysis indicated an under-volume condition near the tread center, with a thickness deviation of -0.69 mm over a width of 15 mm, highlighted in red. This indicates that the dimensional value in the specified area does not comply with the required standard (out of specification), where the allowable tolerance for tread thickness is 0.3 mm. Based on previous inspections, the light tread defect was consistently identified at the same tire location.

Fig. 8. Dimensions of the groove area near the center of the tread.

The optical laser profilometer measurements revealed that the detected defect was consistently concentrated in the center tread region. Quantitative analysis indicated a thickness deviation of -0.69 mm over a width of 15 mm, exceeding the allowable tolerance limit of 0.3 mm. This finding confirms the presence of a localized under-volume condition, which represents a systematic geometric deviation rather than a random manufacturing variation.

Therefore, corrective action was required on the tread die (mold) by increasing its thickness or material volume through controlled material removal (grinding/filing), as shown in Fig. 9.

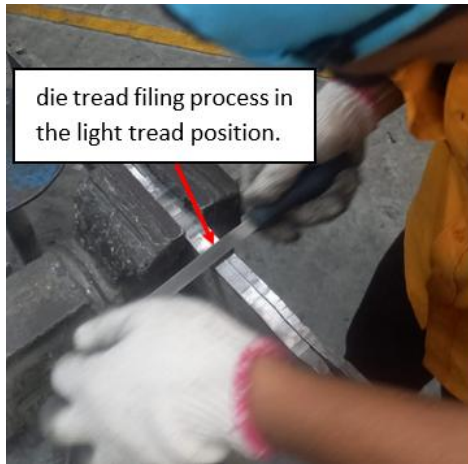
The occurrence of the light tread defect in the center tread region indicates a dimensional inconsistency in the die geometry

Fig. 11. Repair process of tread die.

that affects the tread gauge during extrusion. Therefore, a corrective repair procedure was performed on the upper plate and lower plate sections of the tread die. The repair process implemented on these components is presented in Fig. 11.

As shown in Fig. 11, the dimensional correction process was carried out by increasing the tread gauge height in the cap tread region to achieve the desired tread profile specification. Prior to the modification process, the initial and target die dimensions were measured with a vernier caliper to ensure dimensional accuracy and consistency with the required extrusion profile. Subsequently, a

precision filing process was applied to the tread die surfaces, particularly on the lower plate and the second plate, in the areas associated with the defect. This process aimed to adjust the die geometry and improve the distribution of compound flow during extrusion.

Following the filing process, the modified dimensions were re-measured using a vernier caliper to verify that the targeted dimensional adjustments had been achieved. The repaired die was then reinstalled in the tread extrusion line and used to produce tread material under the modified die configuration.

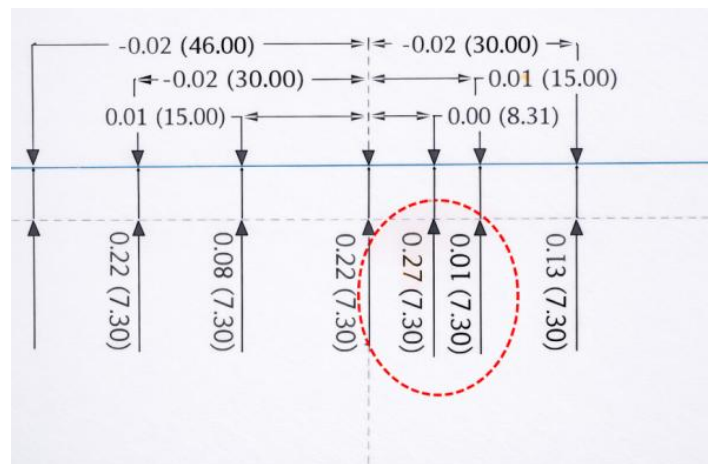
The improvement results are presented in Fig. 13, which shows that the post-repair dimensions met the specified requirements. Based on these results, tread material production was subsequently carried out to enable tire performance testing.

Fig. 13. Tread dimensions after repair.

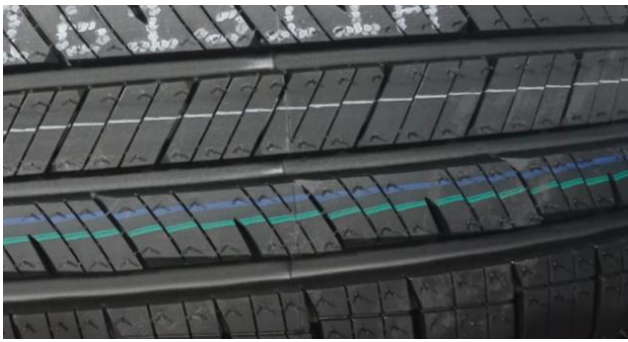
Following the die-tread modification and tread production process, the manufactured tread was assembled into a green tire and subjected to the curing process. The post-improvement evaluation results are shown in Fig. 14, revealing a significant improvement in tread quality. The light tread defect previously observed in the

center tread area was no longer detected after implementation of the corrective actions. This confirms that the dimensional deviation of the tread die was the primary root cause of the defect and demonstrates that the proposed improvement method was effective in eliminating the defect and improving overall product quality.

Fig. 14. Tire results after die repair.

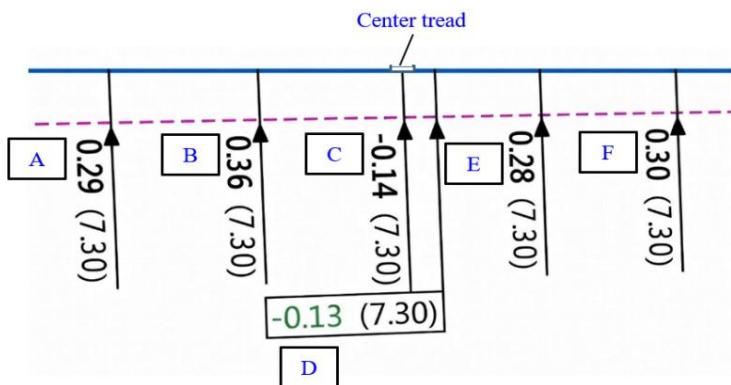
There are 6 dimension checking points in the tread area as shown in Fig. 15. Based on the checking data, the dimensions obtained are 7.30 thick in sections A–F, which as shown in Table 1.

Fig. 15. Dimension checking after die repair.
