## Corrosion Rate Analysis on SA 240 TP 904L Material Experience Multiple Repair

Muhamad Ari\*, Dika Anggara, Amar Sastra Adi

Welding Engineering Study Program, Shipbuilding Engineering Department, Shipbuilding Institute of Polytechnic Surabaya, Surabaya, 60111, Indonesia

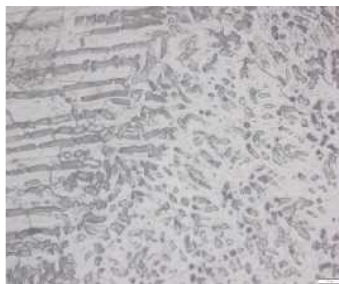
**Fig. 1.** Formation of chromium carbide on fusion lines and HAZ. [4]

The effect of multiple repairs on 304L material also results in lower tensile strength and corrosion resistance, Fig. 1 [4]. The decrease in corrosion resistance in austenitic stainless steel materials is due to increased ferrite content due to repeated heat input.

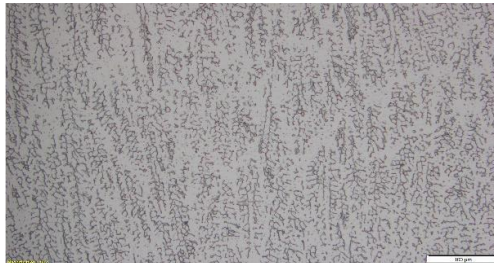
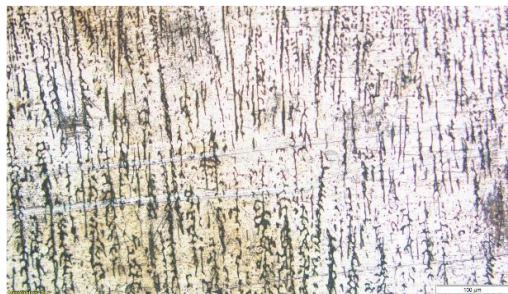
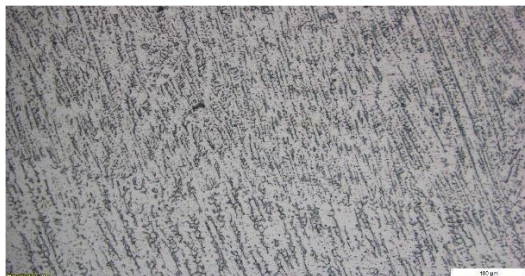
**Fig. 5.** Microstructure of weld metal (a) without repair, (b) repair 1x, (c) repair 3x, and (d) repair 5x [10].

It is clear from looking at the results of the microstructure test that the most significant effect takes place in the lower area of the weld metal. This is because the area affected by repeated repairs is the lower weld metal. The phase structure formed where melting occurs (the weld metal) is typically a delta ferrite structure (primary ferrite), which is shown in black, and austenite, which is shown in white. The outcomes of the microstructure metallographic examination are depicted in Figs 4(a)–4 (d).
