### Effect of welding repair on mechanical properties of ASTM A36 carbon steel weld joints

Azwinur<sup>1\*</sup>, Syukran<sup>1</sup>, Akhyar<sup>2</sup>, Nguyen Huu Tho<sup>3</sup>, Jaswir<sup>1</sup>

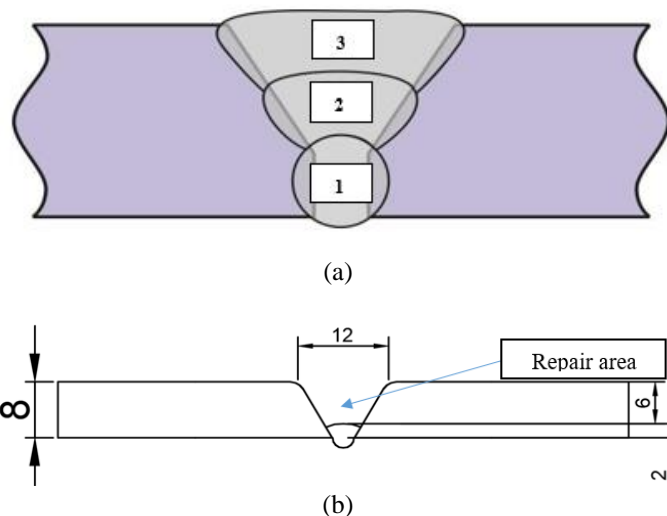
**Fig. 2.** (a) Number of welding layers. (b) Repair area.

Welding with a current of 65-70 Amp for penetration (root) and 90-110 Ampere for filling and closing. Repair for 4 variations of welding, namely without repair, repair 1 time, repair 2 times, and 3 repair. The grinding technique is carried out for the repair process with a depth of 70% of the material thickness and re-welding until it reaches the capping. Welding is carried out for the four types of specimens with a total of 3 layers, starting from the penetration (root pass), filling and capping as shown in Fig. 2

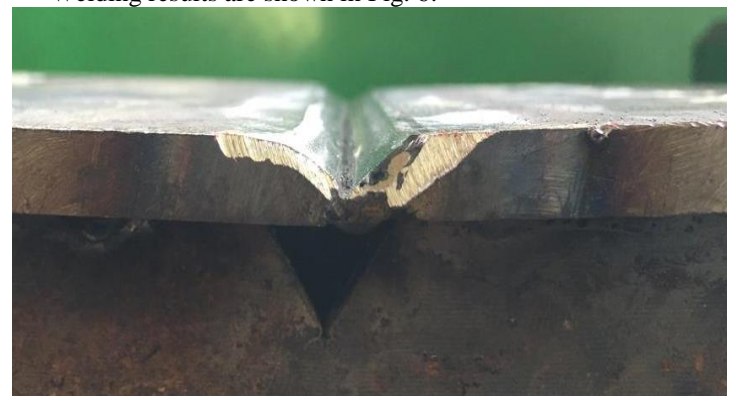
**Fig. 6.** Root welding

The picture above is a welding process on the root or root pass. This is welding on the first layer which is the initial welding of a welding process. After root welding, before proceeding to hotpass

Welding results are shown in Fig. 6:

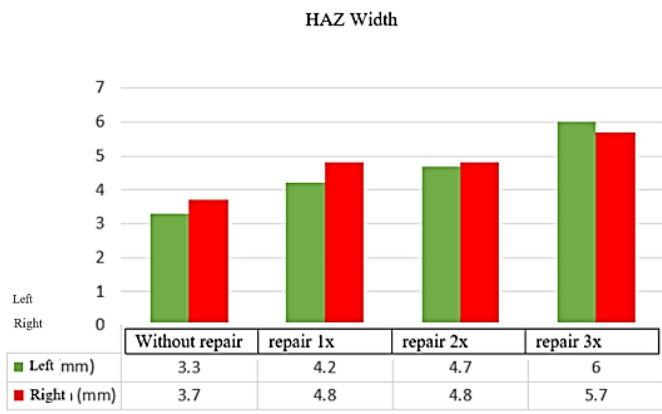
Based on the results of macro photos, data on the HAZ width comparison between the left and right of the weldmetal is shown in Fig. 12. It can be explained that the results of measuring the HAZ width from the left and right of the weldmetal and the results obtained were a widening of the HAZ specimen for 1 repair and then increased in the 2 repair specimen and the highest HAZ width was in the 3 repair specimen.

Fig. 12. Left and right HAZ width comparison chart.

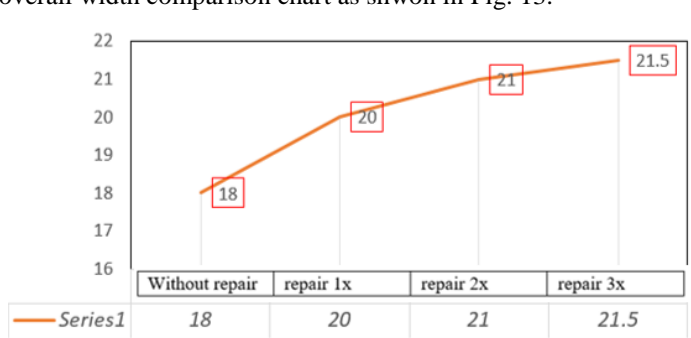
Fig. 13. HAZ overall width comparison chart.

From fig 13, it can be concluded that there is no welding defect in the test specimen. The widest HAZ propagation area was found in 3 repair specimens with a total length of HAZ and weldmetal of 21.5 mm, followed by 2 repair specimens of 21 mm, 1 repair specimen 20 mm and the smallest HAZ propagation area was found in unrepaired specimens with a length of 18 mm. so it can be concluded that the result of the welding repair process greatly affects the widening of the HAZ area due to repeated heat input to cause the width of the HAZ of a welded joint and when associated with the tensile test value and hardness test which decreases the hardness value and hardness value that occurs in specimen 3 repair times while the wider HAZ width is found in the 3 repair specimens. It can be concluded that the more the repair process, the lower the hardness and tensile strength values and the increasing widening of the HAZ width.

The cause of the increasing HAZ widening, starting from the lowest in the specimen without repair and the highest in the 3 repair specimen, was caused by repeated heat input due to repeated welding processes at the same point according to the number of repairs in each type of repair variation. The HAZ overall width comparison chart as shown in Fig. 13.
