Analysis of Hydro Test Pressure Variations on A106 Grade B Carbon Steel Pipe Welded Joints with Welding Repair Method

Riswan E.W. Susanto¹, Kris Witono², Agus Setiawan³, Risno Bayu⁴

Jurusan Teknik Mesin, Politeknik Negeri Malang

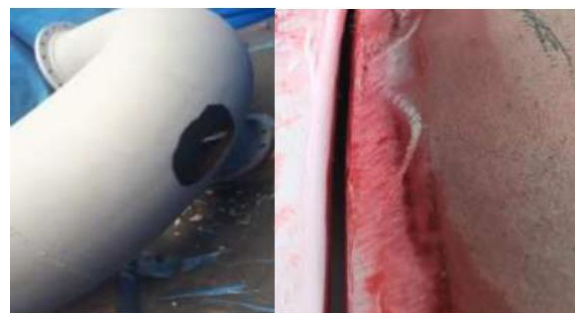
Fig. 2 A106 Gr. B Carbon Steel Pipe (U Tube Seal Deck shaped)

Stage 1. Preparation of the cutter or remove of the existing 90° elbow and neck Flange, cutting or removing the existing 90° elbow will be replaced, and cutting or removing the flange neck joint on the elbow 90°. The accuracy of the cutting area needs to be considered in order to minimize excessive damage to adjacent locations, the flange neck (A106 Gr.B Carbon Steel pipe) will be reattached to the new elbow 90°.

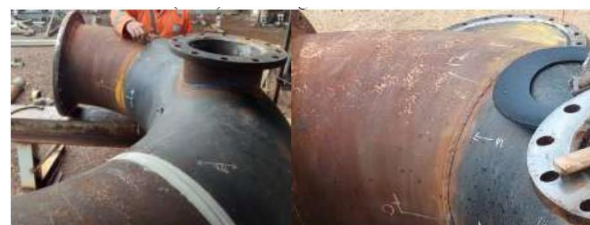
Fig. 3 A106 Gr. B Carbon Steel Pipe (U Tube Seal Deck shaped) cleaned of paint layer and cut [7]

Stage 2. Cleaning and preparing the bevel as needed, the cleaning action will be done by removing rust and painting all elbows 45° (2 pieces) as well as flanges & necks of A106 Gr. B Carbon Steel Pipe

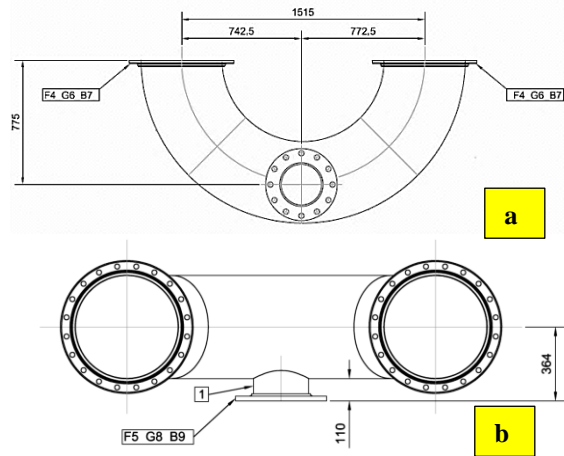
Fig. 6 Dimensions and Material of A106 GR.B Carbon Steel Pipe (U Tube Seal Deck shaped) a. Upper cross section, b front cross section [6]

Attach the neck of the existing A106 Gr.B Carbon Steel Pipe to the new Elbow 90° as per the original drawing and the existing WPS (WPS/CS/EM/ASME/WPxxx) [6].

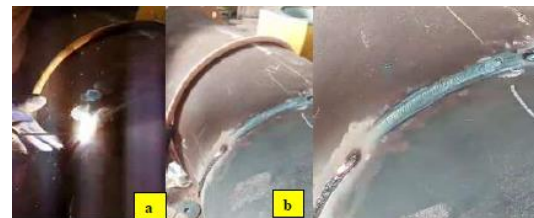
Fig. 7 a. SMAW Welding Process and b. SMAW weld results on A106 Gr.B Carbon Steel Pipe

Stage 5. Welding as needed, performing new welding at a 45° elbow-like joint to a 90° elbow, also welding the flange neck section of the A106 GR.B carbon steel pipe to elbow 90° refers to WPS, and approved image [4].

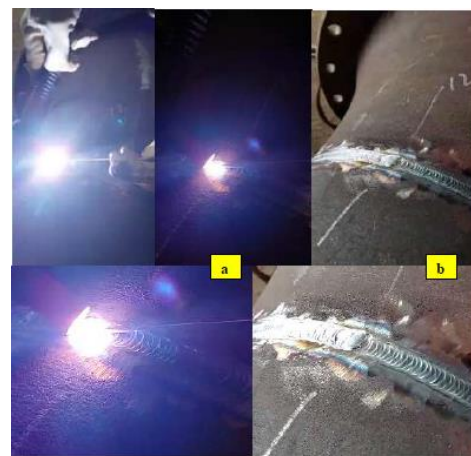
Fig. 8 a. GTAW Welding Process and b. GTAW weld results on A106 Gr.B Carbon Steel Pipe

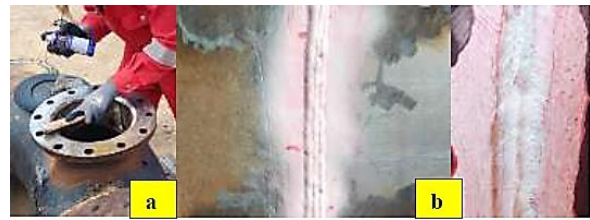
Fig. 10. Penetrant Test Process and b. ASME/ANSI B31.3 Procedure Penetrant Test Results [3]

Stage 8. NDE testing after machining, by applying PT (Penetrant Test) to ensure the flange is free from

any discontinuities, cracks, tears after the machining process.

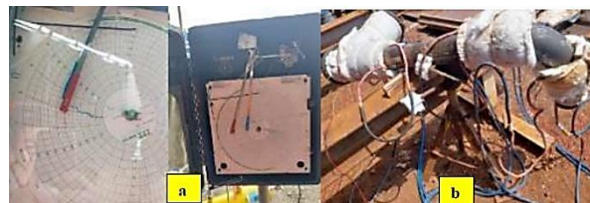
Fig.11 Hydrotest test and measuring equipment (a.Barton chart recorder, 0 – 1500 Psi, b.Hydrotest Pipe)

Stage 9. Hydro test, by applying hydro testing to ensure flanges and welded joints are free from leakage, in accordance with the hydro testing scheme with pressure kPa./Psi.

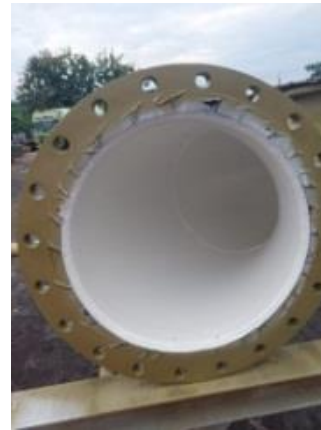
Fig. 14 Coating/coating of A106 GR.B Carbon Steel Pipe (in the form of U Tube Seal Deck)

Stage 10. Painting/Coating, Painting applied to welded joints and all affected areas refers to the A/C coating system in red. See Approved painting standards and procedures as follows: a) Zinc Rich Epoxy (manufacturing color standard) 100 μm, b) Epoxy Mastic (manufacturing color standard) 200 μm, c) High Build Epoxy (manufacturing color standard) 200 μm, 4. Urethan (Red) 60 μm.

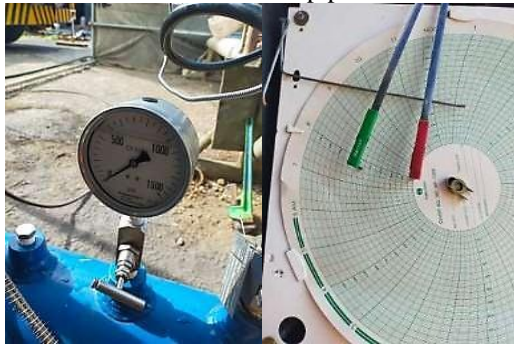
Fig. 15 Pressure 0 Psi and Chart Recorder 0 Psi

- a. Initial pressure of 0 Psi in the hydrotest process of A106 GRB carbon steel pipe.

Tahap pertama melakukan *Pressurizing* pada *hydrotest* di mulai dari 0 psi tekanan pada jarum *pressure gauge* harus menunjuk di angka 0 dan pada recorder barton menunjuk di titik 0, di titik 0 ini menunjukkan akan di lakukan proses tekanan pipa yang berkelanjutan pada proses *hydrotest* pipa baja karbon A106 GR.B.

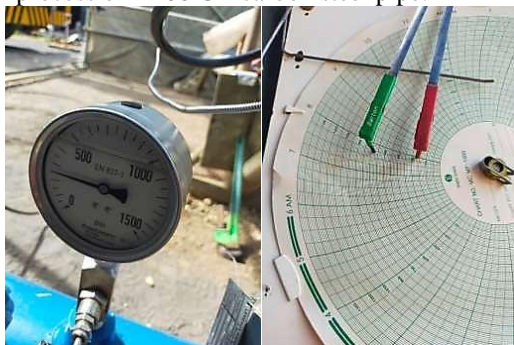
Fig. 16 Pressure 240 Psi Chart Recorder Pressure 240 Psi

- b. Initial pressure of 240 Psi in the hydrotest process of A106 GR carbon steel pipe. B

The second stage is to do an inject at a pressure of 240 Psi the pressure on the pressure gauge needle must point at 240 Psi and at the barton recorder pointing at the point of 240 Psi at this stage the process of increasing the pressure on the pipe is allowed to stand for 10 minutes to find out this process the pipe has a leak or not if it does not have a pipe leak is increased again at the next pressure in the hydrotest process of the A106 GR.B carbon steel pipe.

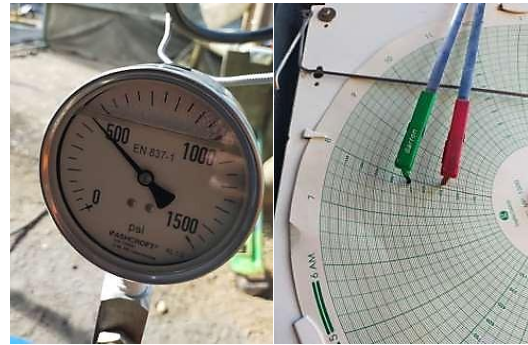
Fig. 17 Pressure 435 Psi Chart Recorder Pressure 435 Psi

- c. Initial pressure of 435 Psi in the hydrotest process of carbon steel pipe A106 GR.B.

The third stage is the increase in pressure from 240 Psi to 435 Psi if the pipe does not have a leak in the inject at a pressure of 435 psi the pressure on the pressure gauge needle must point at 435 Psi and on the barton recorder point at the point 435 Psi at this stage the process of raising the pressure on the pipe is allowed to stand for 10 minutes to find out this process the pipe has a leak or not if it does not have a pipe leak is raised again on further pressure on the hydrotest process of carbon steel pipe A106 GR.B.

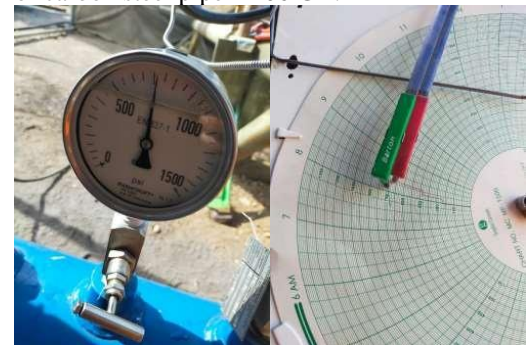
Fig. 18 Pressure 690 Psi Chart Recorder Pressure 690 Psi

- d. Initial pressure of 690 Psi in the hydrotest process of carbon steel pipe A106 GR. B

The fourth stage is the increase in pressure from 435 Psi to 690 Psi if the pipe does not have a leak in the inject at a pressure of 690 Psi the pressure on the pressure gauge needle must point at 690 Psi and on the barton recorder point at the point of 690 Psi at this stage the process of increasing the pressure on the pipe is allowed to stand for 10 minutes to find out this process the pipe has a leak or not if it does not have a pipe leak is raised again on further pressure on the hydrotest process of carbon steel pipe A106 GR.B.

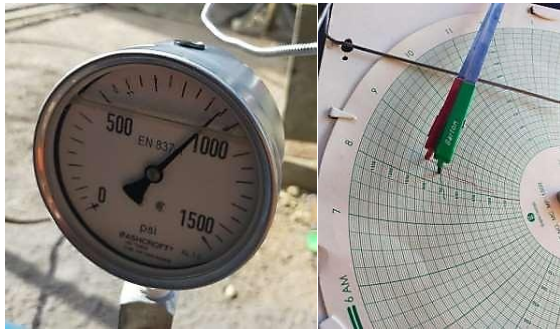
Fig. 19 Pressure 915 Psi Chart Recorder Pressure 915 Psi

- e. Initial pressure 915 Psi in the hydrotest process of carbon steel pipe A106 GR.B.

The fifth stage is the last increase in pressure from 690 to 915 if the pipe does not have a leak in the inject at a pressure of 915 Psi the pressure on the pressure gauge needle must point at 915 Psi and on the barton recorder point at the point 915 Psi at this stage the pressure increase process on the pipe is allowed to stand for 1 hour to find out this process the pipe has a leak or not if it does not have a leak then the pressure drop process (Depressurizing) on the hydrotest process of carbon steel pipe A106 GR.B. penurunan tekanan (*Depressurizing*) pada proses *hydrotest* pipa baja karbon A106 GR.B.

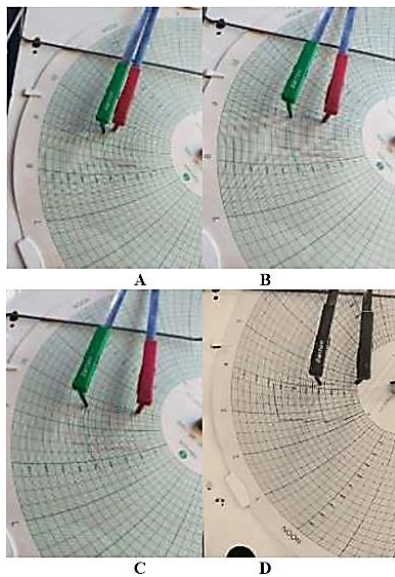
Fig. 20 Proses *depressure* A. Release 75% B. Release 50 %, C. Release 25 %, D. Release 0%

The sixth stage is the Release of 75% decrease in pressure from 915 Psi to 690 Psi after passing the stage of being let stand for 60 minutes in the pressure drop process must also wait 10 minutes in this process, if the pipe does not experience a leakage of the Carbon Steel A106 Gr.B hydrotest process.

The seventh stage is the Release of 50 % decrease in pressure from 690 Psi to 435 Psi in the pressure drop process waiting 10 minutes in this process, if the

pipe does not leak the Carbon Steel A106 GR.B hydrotest process.

The eighth stage is the Release of 25% decrease in pressure from 435 Psi to 240 Psi in the pressure drop process waiting 10 minutes in this process, if the pipe does not leak the Carbon Steel A106 GR.B hydrotest process.

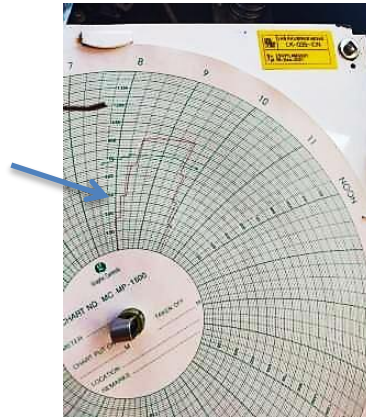
Fig. 21 Hydrotest Results of A106 GR carbon steel pipe. B (shown on the arrow) hydrotest carbon steel pipe A106 GR.B.

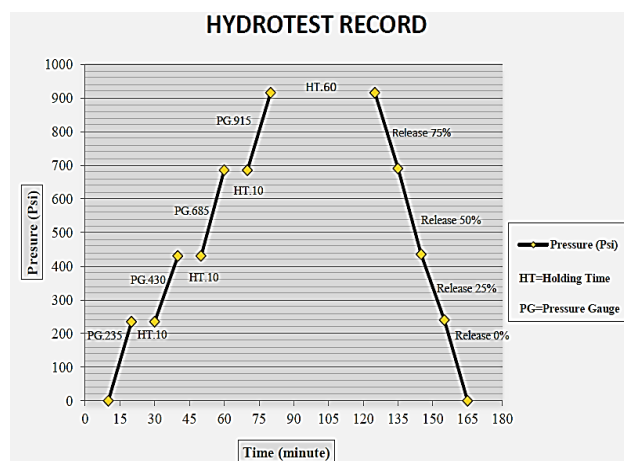
Fig. 22 Hydrotest Results Graph of A106 GR.B carbon steel pipe.

The ninth stage is the Release 0% decrease in pressure from 240 Psi to 0 Psi in the reduction process and the last stage of the hydrotest process of the A106 GR.B carbon steel pipe, the barton chart results are shown in figure 22.

The results of the hydrotest process of carbon steel pipe A106 GR.B can be read through the barton chart decreased or increased the pattern of ink lines due to temperature changes at the time of conducting the test and on the A106 GR.B carbon steel pipe has no effect at all on cold or hot temperatures.

From figure 23 above, the results can be obtained that the pressure change is divided into two stages of pressure change, the first press is increased by 4

different pressures (pressuring) in each pressure change is held (holding Time) and obtained results without leakage in each welded joint that has been carried out with the highest pressure of 915 Psi, then pressure detention is carried out for 60 minutes and also obtained the results of the welded connection do not leak, and already according to the admission criteria. While the second stage with pressure reduction (depressurizing) with 4 pressure variations or called release where release 100% at a pressure of 915 Psi then release 75% pressure 690 Psi without any time hold obtained results without leakage the next gradually decreased successively 435 Psi, 240 Psi. In the hydrotest test there was no deformation, no deformation and leakage in the welded joint layer of carbon steel pipe A106 Gr.B. In the hydrostatic test, there were no deformations, no deformations and leaks in the welded layer of the A106 Gr.B. carbon steel pipe. B of environmental corrosion needs to be painted / coating process or if it occurs corrosion damage, repairs can be made using the Welding Repair method.
