Evaluation of magnetic particle inspection for optimizing welding quality in back gouging boom structure preparation in heavy machinery

Mechanical Engineering Department, Politeknik Negeri Batam

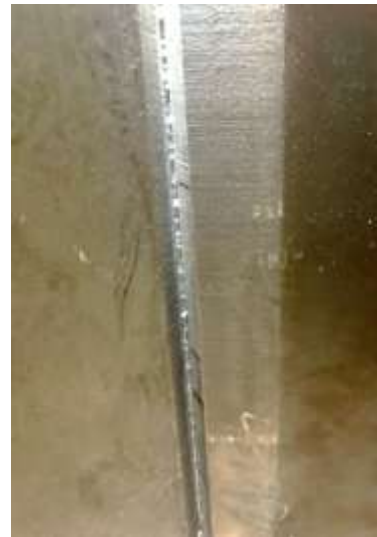
Fig. 4. Welding Seam Before Back Gouging

This study evaluated the effectiveness of Magnetic Particle Inspection (MPI) in detecting welding defects during the back gouging process for boom structures. Data were collected from six Body Serial Numbers (263-268) to compare Defects Per Unit (DPU). The welding process followed the Welding Procedure Specification (WPS), but suboptimal root penetration was observed due to gaps between the plates, as shown in Fig. 4 and Table 5. Factors such as insufficient backing ceramic, inadequate preheating, and poor joint design contributed to these defects.

This finding was attributed to several factors, including the lack of process improvement to add backing ceramic to root preparation, insufficient skills or expertise among welders, joint design with a root face that is too thick, preheating before welding that does not reach the corresponding hot spot WPS, and gaps or root openings that are too wide.

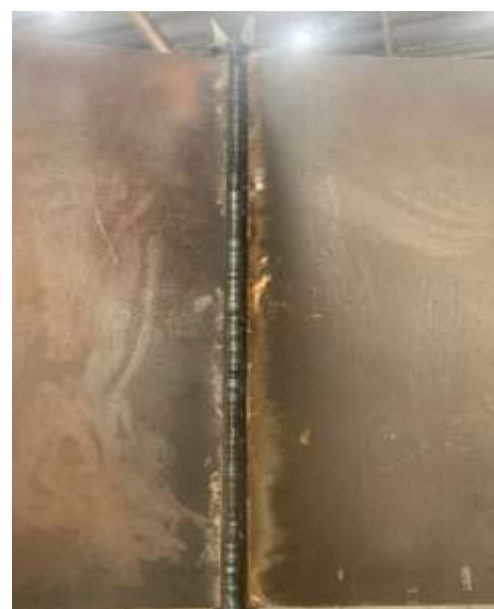
Fig. 5. Welding Seam After Back Gouging Process

Fig. 5 shows that the correct back gouging process yielded good gouging results and uniform grooves. Before conducting the magnetic particle test, as shown in Fig. 6, the joint preparation had to be cleaned of all contamination following the back gouging process.

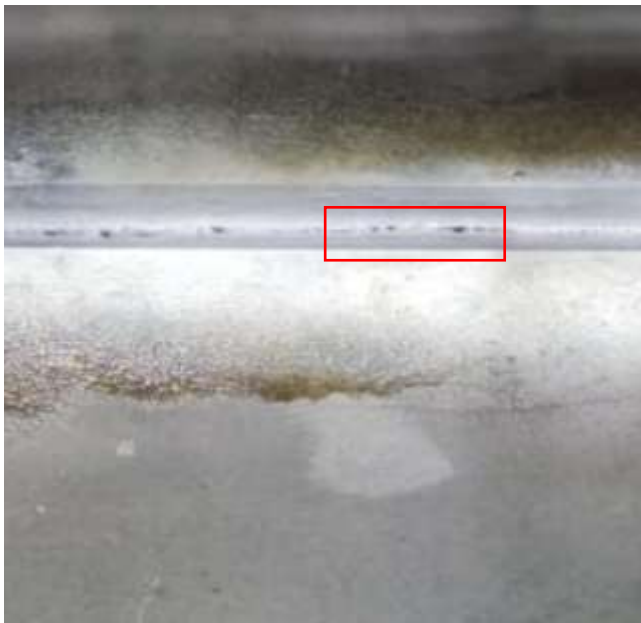
Fig. 7. Linear Indication

Linear indications, caused by surface roughness, contamination, and suboptimal welding parameters, were found across samples, as illustrated in Fig. 7. These indications can occur due to several factors, including suboptimal material cleanliness before welding, which can cause a lack of fusion; using a voltage that is too low, which can also lead to a lack of fusion; and the need for a faster travel speed[11].

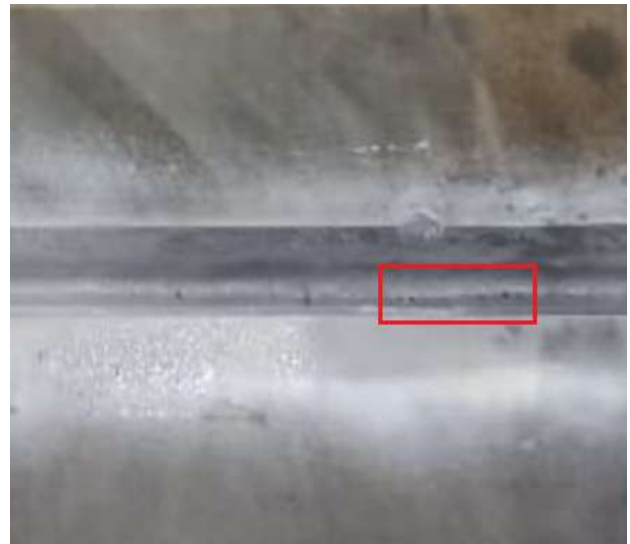
Fig. 8. Rounded Indication

Rounded indications, attributed to porosity and gas flow issues, were less frequent, but still present (Fig. 8). These indications could occur due to porosity during the root process and are caused by several factors, including joint preparation contaminated by water, paint, grease, oil, and other substances; the use of electrodes that are too humid and a lack of preheating before the welding process; strong air or wind gusts that interfere with the flow of shielding gas; gas flow that is too high, causing turbulence and drawing air out; and gas flow that is too low, not providing enough protection for the weld crater[12].

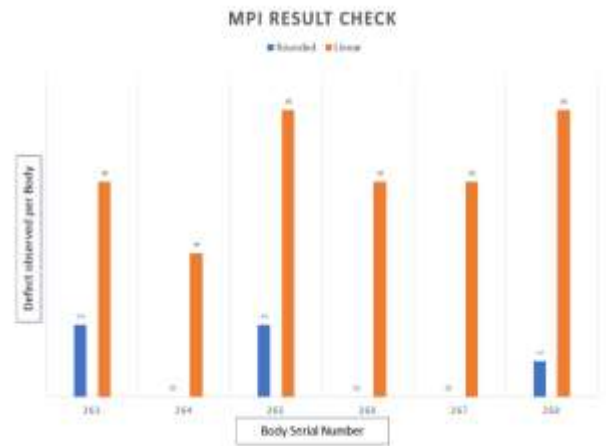
Fig. 9. Chart Data Defect per Unit (DPU)

The following Fig. 9 presents the Chart Data Defect per Unit (DPU) obtained after the inspection and the built-in Quality (BIQ) process. From this data, it is known that the number of defects found in the sample is higher in the form of linear indications than rounded indications. The DPU data highlight Body Serial Number 265 as having the highest defect rate.
