## Comparative analysis on metallography, hardness, and corrosion rate of repair methods in welding tube SA-213 to tubesheet SA-240

Department of Welding Engineering, Shipbuilding Institute of Polytechnic Surabaya, Surabaya 60111, Indonesia

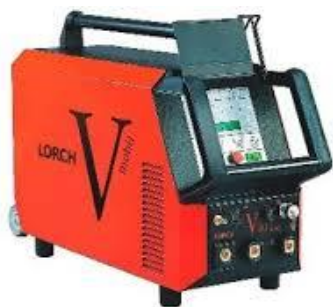
Fig. 1. GTAW Welding Machine

The tube-to-tubesheet welding process in this study used a GTAW (Gas Tungsten Arc Welding) welding machine with predetermined parameters and joint designs. The joint was then assumed to be defective, and three different repair processes were performed: Repair A (repair by TIG dressing), Repair B (repair by flush & reweld with filler metal 1.6 mm), and Repair C (repair by flush & reweld with filler metal 2 mm). The GTAW welding machine is shown in Fig. 1, and the parameter of welding as shown in Table. 1.

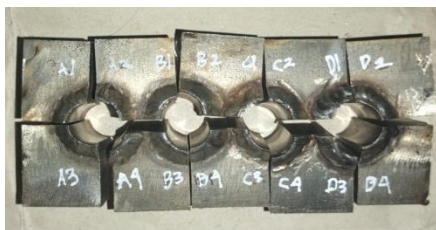
Fig. 3. Test Specimen

Preparation of test specimens by cutting the entire specimen into several parts for metallographic, hardness, and corrosion rate testing. According to ASME IX, macro examination of tube-to-tubesheet welds requires cutting through the tube center, with specimen codes A (without repair), B (repair 1 by TIG dressing), C (repair 2 with 1.6 mm filler), and D (repair 3 with 2 mm filler) in Fig. 3

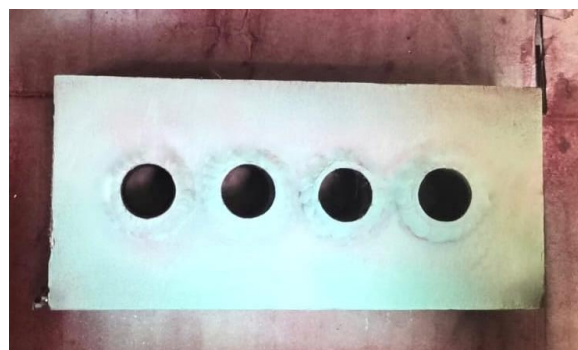
Fig. 6. Penetrant test result

Liquid dye penetrant testing is a non-destructive test to find discontinuities in the surface of the test specimen based on the principle of capillarity[11]. Documentation of the results of the liquid dye penetrant test in Fig. 6.

From Fig. 6, that the welding process on the tube-to-tubesheet joint complies with the acceptance criteria for liquid penetrant in ASME VII DIV 1 APPENDIX 8 [12]. Therefore, the specimen can be said to meet the acceptance criteria, meaning that the welding process has passed the penetrant test and can proceed to the next process without any repeat repairs. This success is due to the welding parameters used not deviating from the qualified WPS.

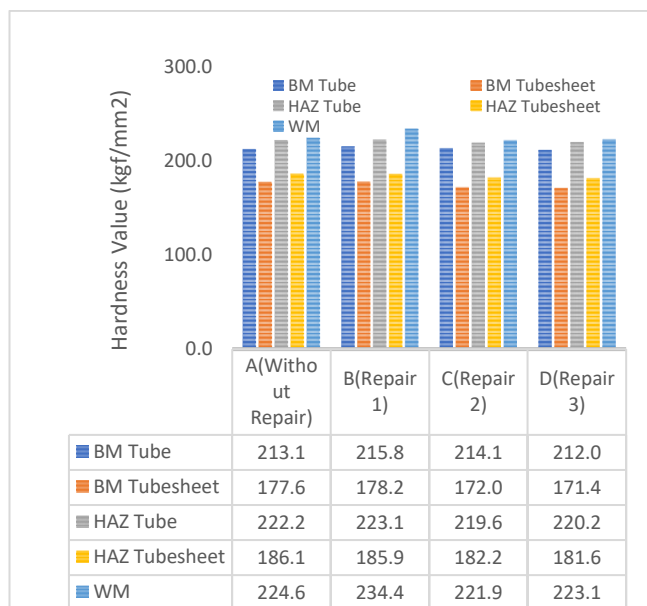
Fig. 16. Hardness Test Chart

Hardness testing was conducted using the Vickers method (kgf/mm<sup>2</sup>) with a load of 1 kgf for 10 seconds. The locations of indentations in the BM, WM, and HAZ regions of each variation and their results in Fig. 16.

The hardness test results for tube-to-tubesheet welds showed variation across different regions, with the highest values generally observed in specimens repaired by TIG dressing (B), particularly in the base metal tube (215.8 kgf/mm<sup>2</sup>), base metal tubesheet (178.2 kgf/mm<sup>2</sup>), HAZ tube (223.1 kgf/mm<sup>2</sup>), and weld metal (234.4 kgf/mm<sup>2</sup>). In contrast, the lowest hardness values were mostly found in specimens repaired by flush & reweld with filler 2 mm (D), while the HAZ tubesheet recorded its highest hardness in the unrepaired specimen (A).

Hardness testing confirmed these microstructural findings. The base metal tube exhibited values between 212.0–215.8 Kgf/mm<sup>2</sup>, which were attributed to cold working during the tube expansion process after welding. The tubesheet recorded values between 171.4–178.2 Kgf/mm<sup>2</sup>, showing little variation since stainless steel is non-heat-treatable and relatively stable in hardness. The HAZ of the tube presented slightly higher hardness, with the highest value recorded in specimen B (223.1 kgf/mm<sup>2</sup>). Notably, the weld metal itself displayed the highest hardness in specimen B, averaging 234.4 Kgf/mm<sup>2</sup>, which is consistent with the presence of more refined ferrite. According to [19], an increase in delta ferrite content correlates with higher hardness, though at the expense of ductility. Importantly, all hardness values remained within the permissible limit of 250 HV specified for stainless steel in the Heat Exchanger Design Handbook [1], confirming the suitability of all repair methods from a mechanical strength perspective.

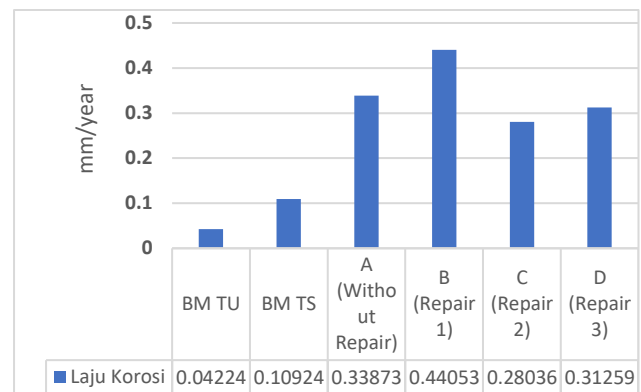
Fig. 17. Corrosion Rate Chart

Corrosion rate testing was conducted to evaluate the effect of various welding repair methods using a 3.5% NaCl solution (pH 6.8) to simulate seawater conditions. Six specimens were tested, including base metal pipe (BMTU), base metal sheet pipe (BMTS), without repair (A), and three repaired specimens (B, C, D). The results in Fig. 17.

The potentiodynamic polarization curves were analyzed using Tafel extrapolation to determine corrosion current density ( $I_{corr}$ ) and corrosion potential ( $E_{corr}$ ), which were then used to calculate corrosion rates. Results showed that base metals had the lowest corrosion rates (0.04224 mm/year for tube and 0.10924 mm/year for tubesheet), while welded specimens exhibited higher rates. Among the repaired samples, the TIG dressing repair (B) showed the highest corrosion rate (0.44053 mm/year), whereas flush & reweld with filler 1.6 mm (C) had the lowest (0.28036 mm/year). These findings indicate that welding and repair processes significantly increase corrosion susceptibility, particularly in the knife zone near the weld, where chromium carbide

The corrosion test provided a different perspective on repair performance. The base metal tube showed the lowest corrosion rate at 0.04224 mm/year, while the tubesheet followed with 0.10924 mm/year. The unrepaired specimen displayed a higher rate of 0.33873 mm/year, reflecting the influence of welding on corrosion behavior. Among repaired specimens, TIG dressing exhibited the highest corrosion rate at 0.44053 mm/year, whereas flush & reweld with 1.6 mm filler achieved the lowest rate of 0.28036 mm/year. Corrosion was predominantly observed in the knife zone, the thin region between the weld metal and the HAZ, where chromium carbide (Cr<sub>23</sub>C<sub>6</sub>) precipitation at grain boundaries disrupts passive film stability. As explained by [14], this phenomenon reduces corrosion resistance locally, even when the bulk stainless steel material remains resistant. These findings indicate that although TIG dressing improves hardness, it compromises corrosion performance more than the other methods.
