Evaluation Of Category III Overhead Tools Inspection Rig X PT. BMS

Bambang Yudho Suranta^{1*}, Akhmad Sofyan^{1,2}, Muhammad Hafiz Rahman¹

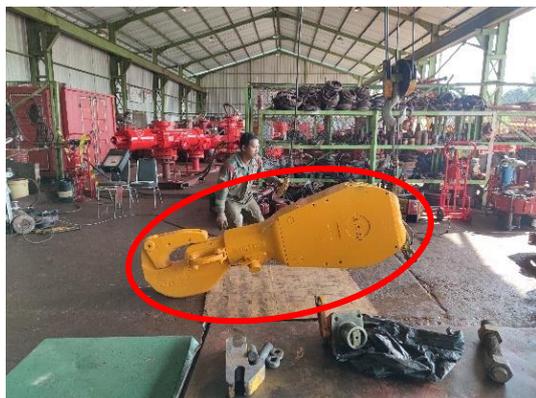
Visual inspection of the traveling block (Fig. 1) is first carried out before all components are dismantled. Then to carry out a more thorough inspection, is carried out when all components are dismantled (as shown in the red arrow Fig. 2) where a more accurate inspection will be carried out by the inspector.

Fig. 1. Traveling block and hook block visual inspection.

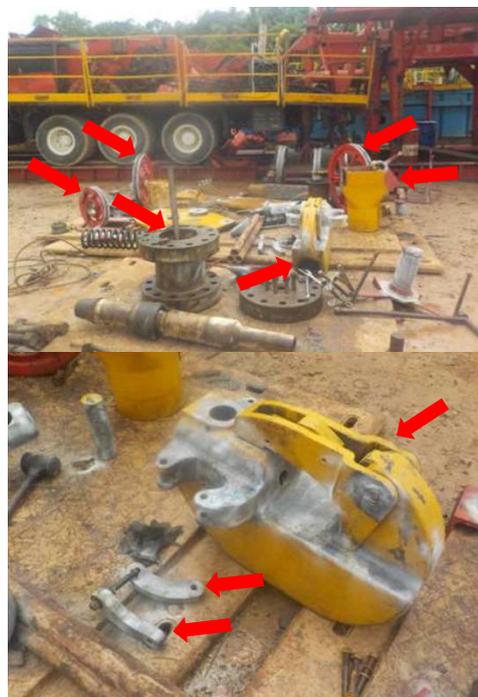
Magnetic particle inspection is also carried out on all components of the traveling block (Fig. 2), this inspection process aims to find defects or defects that are more accurate to the components of the traveling block using magnetic fields [10]. The results of this inspection state that all components of the traveling block are in good condition or no defects are found, and indicate that the traveling block is suitable for use.

Fig. 2. Traveling block and hook block magnetic particle inspection.

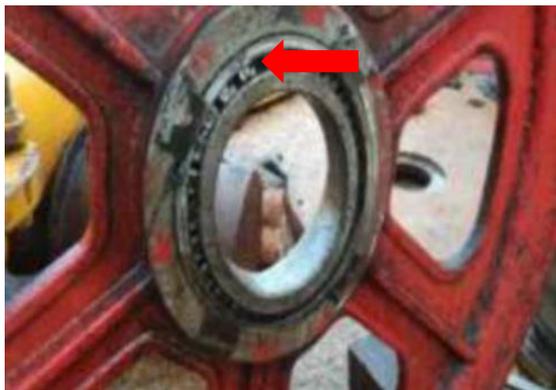
Visual inspection of crown blocks is different from that done in traveling blocks. This inspection was carried out with the position of the crown block components dismantled [11]. The components inspected on the crown block are not too many and complex. There are findings of defects (damaged) in crown block

(as shown in the red arrow Fig. 3) bearings that occur due to friction in the bearing when the crown block is operated [12]. Therefore, the action that must be taken is to replace the bearing so that unwanted incidents do not occur in the next crown block operation.

Fig. 3. Crown block visual inspection.

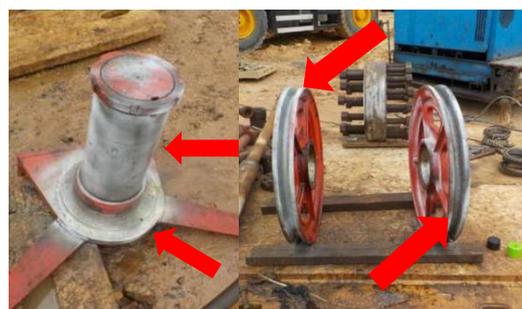
A magnetic inspection process is also carried out on this crown block with the aim of more accurately identifying any defects or defects in the components of the crown block. The results of this inspection stated that the components contained in the crown block were declared to be in good condition without any defects (as shown in the red arrow Fig. 4), thus confirming that the crown block can be used safely and properly, with a record of repairs to parts found during previous visual inspections.

Fig. 4. Crown block magnetic particle inspection.

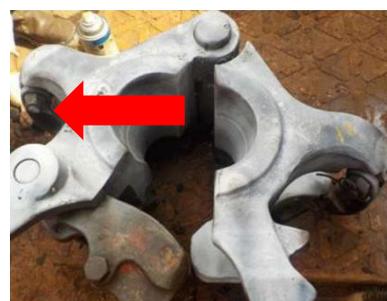
In addition to visual inspection, magnetic particle inspection methods are also used to improve inspection accuracy. This method is very effective in detecting internal damage that may not be visually visible [14], [15]. When the inspection process was carried out, it was found that there were no safety pins installed on bolt tubing elevators (as shown in the red arrow Fig. 5) measuring 2-3/8" and 3-1/2", as well as on DP elevators measuring 2-7/8". When the safety pin is not installed, there is a potential that the elevator bolt tubing or DP elevator will not lock securely and under control during use.

Fig. 5. No safety pin on tubing and DP elevatorbolts.

This may result in uncontrolled movement or possible detachment of the drill pipe from the elevator during operation. This risk can lead to serious accidents, equipment damage, and even injury or loss of life to the operator or surrounding personnel. Therefore, it is important to ensure that the safety pin is properly installed on the elevator bolt tubing.

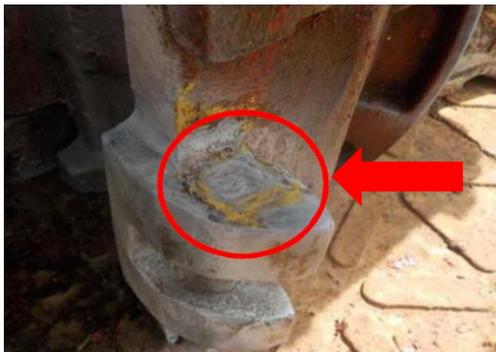
Furthermore, a very serious problem was found, namely a crack in the pin lock tubing elevator door 2-7/8". The finding of cracks in the elevator door pin lock indicates significant structural damage to the elevator (as shown in the red arrow in Fig. 6).

Fig. 6. Crack on pin lock tubing elevator door 2-7/8".

Such cracks may indicate excessive pressure or wear and tear that could potentially result in mechanical failure or loss of safety when the elevator is in use. Therefore, by API RP 8B [16] replacing elevator units with new ones is considered the most appropriate step to ensure operational reliability and safety.

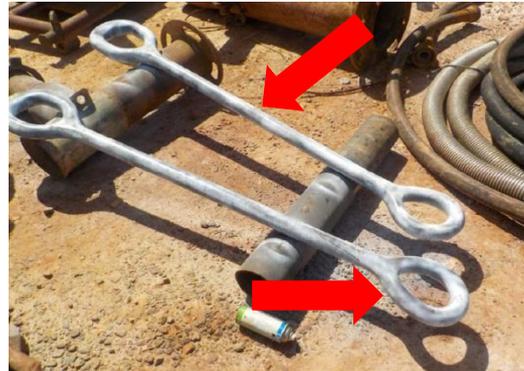
The results of the inspection process concluded that the elevator link was in good condition and showed no indication of any problems or risks that could endanger operations (as shown in the red arrow Fig. 7). This means that such link elevators can be used with confidence that their performance will meet safety standards and can withstand the loads and stresses associated with drilling operations.

Fig. 7. Elevator link inspection.

In this context, the decision to use elevator links is based on the results of a comprehensive inspection. These results assure that the component has met safety requirements and can be relied upon for use in operation. However, it is important to continue to conduct regular monitoring and inspection of elevator links to

ensure that their feasibility and reliability are maintained during long-term use.
