Impact of welding steel rod rotor bars on ripple mill efficiency and cost-effectiveness at Sumatera Jaya Agro Lestari Sawit Coconut Plant

Abstract

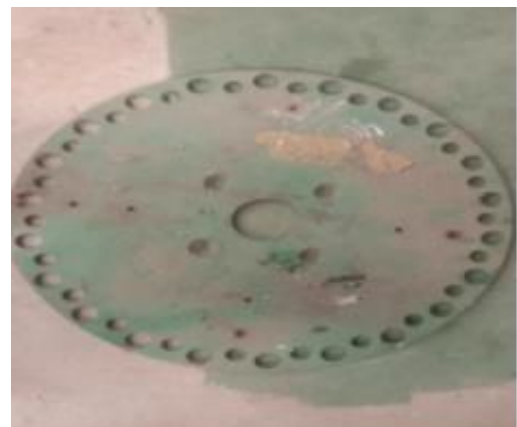
The rotor disc is one of the components of a rotor bar that determines the position of the bar (Fig. 2).

Fig. 2. Rotor disc(source: PT. Sumber Jaya Agro Lestari).

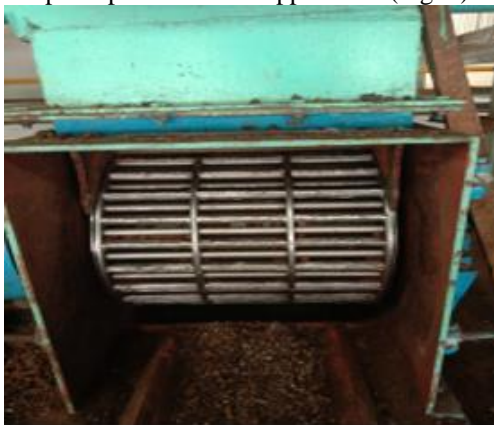
Rotor bars are pile-shaped axes around rotors used to place palm seeds in ripple mills. Rotor bars are pile-shaped axes around rotors used to place palm seeds in ripple mills (Fig. 3).

Fig. 3. Rotor bar (source: PT. Sumatera Jaya Agro Lestari).

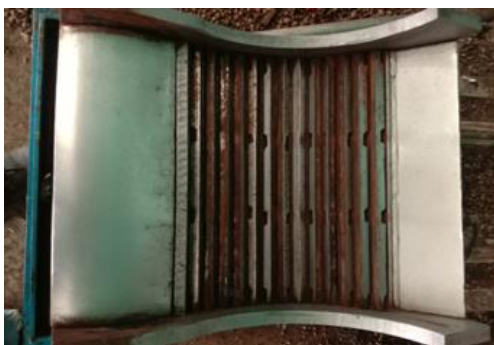
The ripple plate is commonly referred to as the seed breaker wall. As seeds are carried by the rotor, they will be thrown under pressure against this wall, causing them to break apart. The ripple plate is fitted to the walls of the container to create pressure on the seeds [17][18] (Fig. 4).

Fig. 4. Ripple plate (source: PT. Sumatera Jaya Agro Lestari).

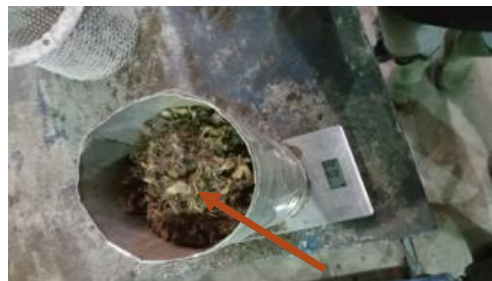
In the operation of the ripple mill that passed the recommended service life of the manufacturer. Therefore, there is a need for rigor to be able to analyze, select and use effective tools in the process to find optimal processing costs with good performance so that it can be a good input to the palm coconut plant. The method used to obtain research data is to take samples 1 and 2 by taking 1 kg of kernel nut. 1 kg is one sample placed on the kernel nut filling with a note that should not be too much resulting in the steel rod suffering depletion so that the square bar is dull and the rotor bar is bent overwhelming the breakage ineffective (Fig. 5).

Fig. 5. Samples before welding.
