Vibration-based detection of blower bearing defects using FFT and envelope analysis to improve machine reliability

Rolling bearing failure in blower machines can disrupt plant operations, increase maintenance costs, and trigger unplanned shutdowns. This study aims to detect early-stage bearing damage in a blower unit at Plant Sabiz using vibration signal analysis. Vibration data were acquired using an SKF Microlog Analyzer CMDT 391 and evaluated using Fast Fourier Transform (FFT) and envelope analysis to identify defect-related frequency components. The results revealed an increase in velocity vibration up to 4.87 mm/s and envelope vibration up to 34.4 gE. The FFT spectrum showed dominant harmonics from 1xRPM to 3xRPM, indicating dynamic imbalance and potential damage to rotating components. Furthermore, envelope analysis identified bearing characteristic frequencies, particularly the Fundamental Train Frequency (FTF) and its harmonics, specifically pointing to cage degradation. This pattern was reinforced by the non-dominance of Ball Pass Frequency Outer Race (BPFO) and Ball Pass Frequency Inner Race (BPFI) frequencies, which ruled out damage to the outer and inner races. Visual

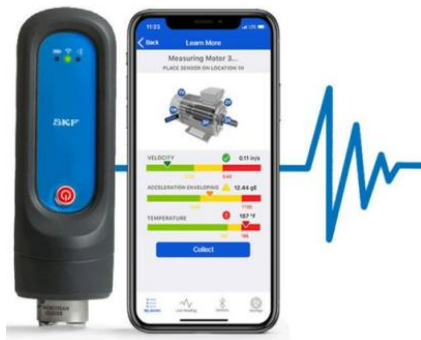
Fig. 3. SKF microlog analyzer (CMDT 391)

Some of the research tools used are as follows. First, a 49.61 HP (37 kW) WUDF 2225 S electric motor equipped with an inverter, hook spanner, torque wrench, and stroboscope. Then, an SKF Microlog Analyzer (CMDT 391) was used to measure bearing vibration. In addition, a computer with SKF Analysis and Reporting Manager installed is also used. This tool is connected to a smartphone using a bluetooth network so that it can be used to collect vibration data.

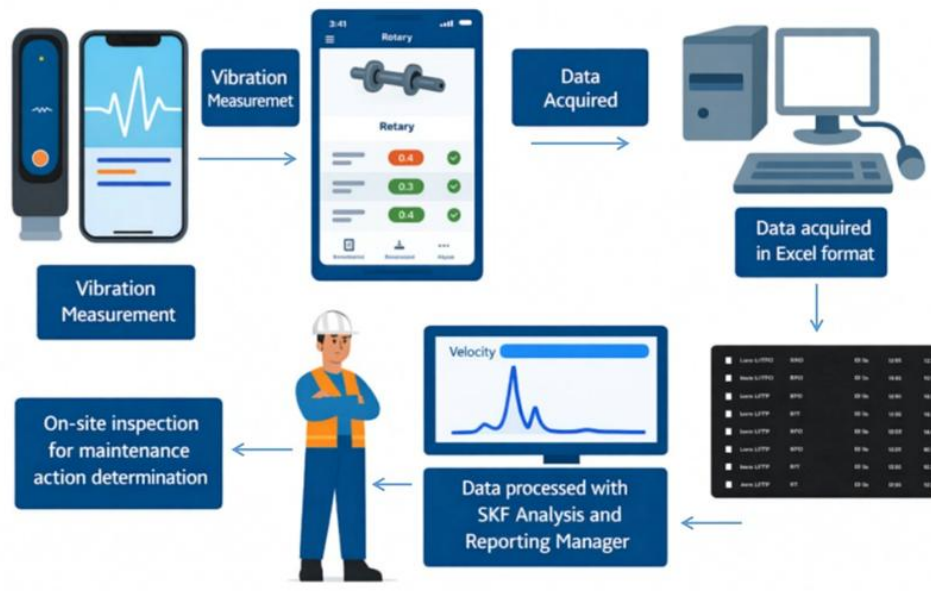
Fig. 5. Research method flow

Based on this workflow, the bearing defect identification process is carried out in a structured manner starting from data collection, signal processing, to maintenance decision making, thus supporting the implementation of condition-based maintenance and increasing the reliability of the blower machine.

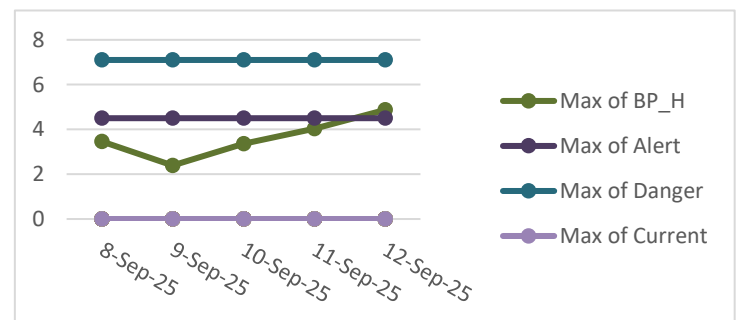
Fig. 7. Velocity graph

Fig. 7 shows a velocity graph with the development of the maximum vibration value in the horizontal direction (BP_H) during the observation period of September 8-12, 2025, compared to the Alert and Danger threshold limits. It can be seen that the BP_H value fluctuates and increases gradually until it reaches its highest value on September 12, 2025, approaching the Alert limit. This increasing pattern indicates a progressive degradation of the bearing condition, which is generally related to the instability of the bearing's internal elements such as the cage.

In this study, the frequency values of FTF can be seen in Fig. 6 and 7. This figure shows a significant increase from day to day which results in fatal damage to the bearings and causes losses to the company.

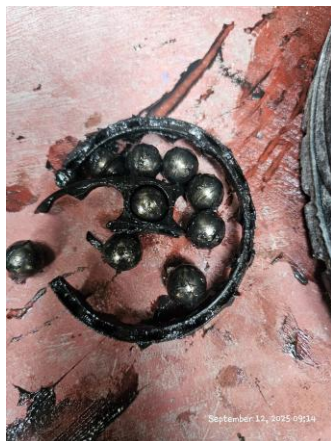
Fig. 10. Broken cage

Fig. 10 shows the actual condition of the rolling bearing after disassembly, where severe damage is visible to the cage section, marked by a broken cage structure and the release of the rolling elements (balls). This damage indicates progressive mechanical degradation due to repeated dynamic loads and high vibration excitation during blower operation. Cage failure causes the bearing to be unable to maintain the position and clearance between the rolling elements, thus triggering abnormal contact, increased friction, and vibration spikes. This physical condition aligns with the previous FFT and envelope spectrum analysis results, which showed the appearance of FTF frequencies and their harmonics, which are characteristic of cage damage in rolling bearings. This visual inspection validates the vibration signal-based diagnosis results and confirms the effectiveness of the FFT and envelope analysis method in detecting bearing defects early before total failure occurs.
