## Influence of machining parameters on cutting performance and wear mechanisms of coated carbide tools

### Abstract

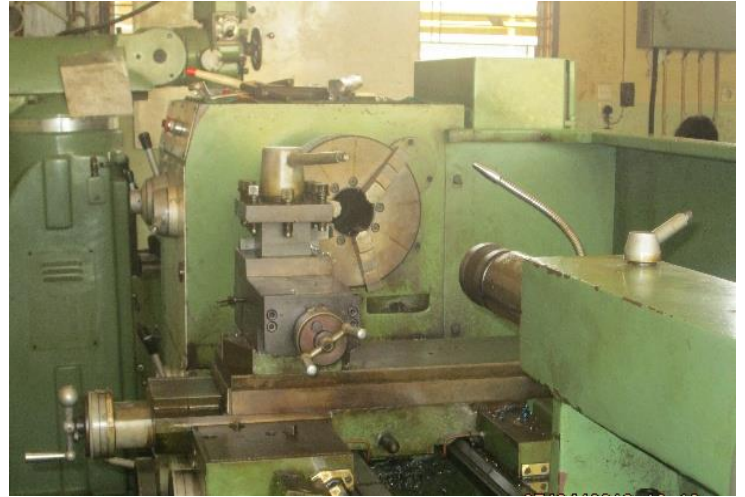
The turning process was conducted using a CD 6260-C lathe. The technical specifications of the machine are depicted in Fig. 6.

Fig. 6. CD 6260-C turning machine

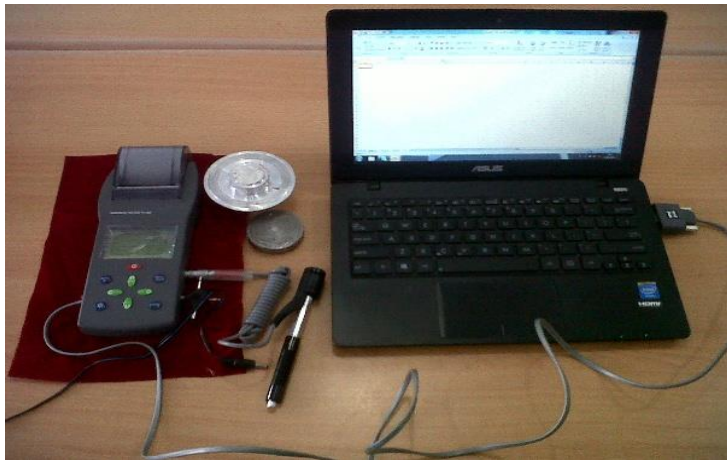
To measure the hardness value of the material, it was analyzed using a portable hardness tester, as depicted in Fig. 7.

Fig. 7. Portable hardness tester

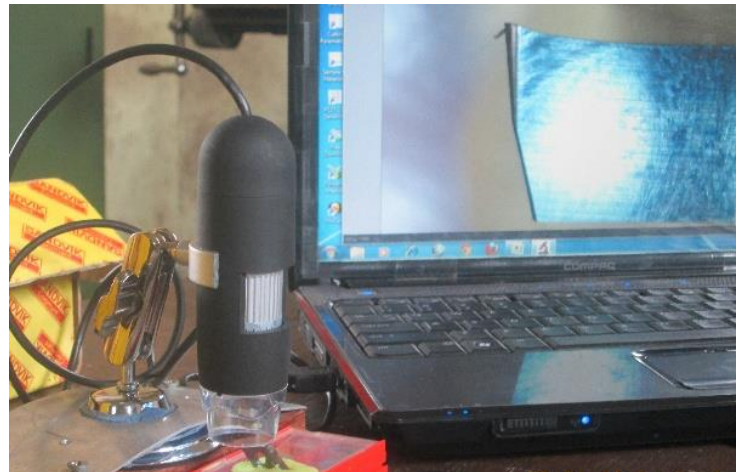
Initial tool wear after machining was documented using a USB-based digital microscope imaging system. The system was equipped with dual-axis optical lenses providing magnifications of  $27\times$  (working distance 8 mm) and  $100\times$  (2 mm). The experimental setup of the USB digital microscope as depicted in Fig. 8.

Fig. 8. USB digital microscope

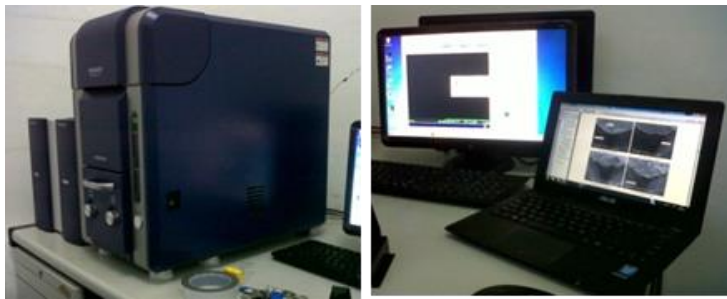
Microstructural and surface morphology analyses were conducted using Scanning Electron Microscopy (SEM) at a magnification of  $20,000\times$ . SEM is used to generate high-resolution images of surface topography and microstructural features through a focused electron beam, while elemental composition is analyzed using an integrated EDS system. The SEM-EDS instrument was used in this study as depicted in Fig. 9.

Fig. 9. Scanning electron microscopy with energy-dispersive X-ray spectroscopy

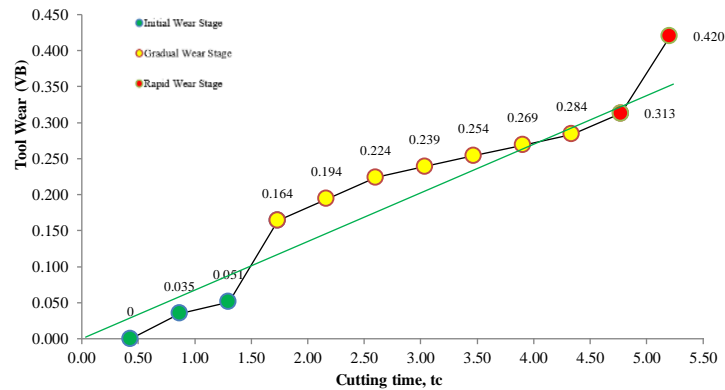
Fig. 10. Edge wear progression curve for Al-6061 at cutting speed 385 m/min, feed rate 0.15 mm/rev, cutting depth 1.5 mm

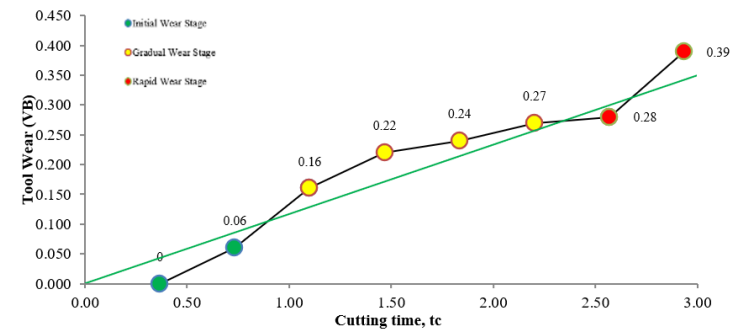
Fig. 13. Edge wear progression curve for AISI 1070 at cutting speed 111 m/min; feed rate 0.15 mm/rev; cutting depth 1.5 mm

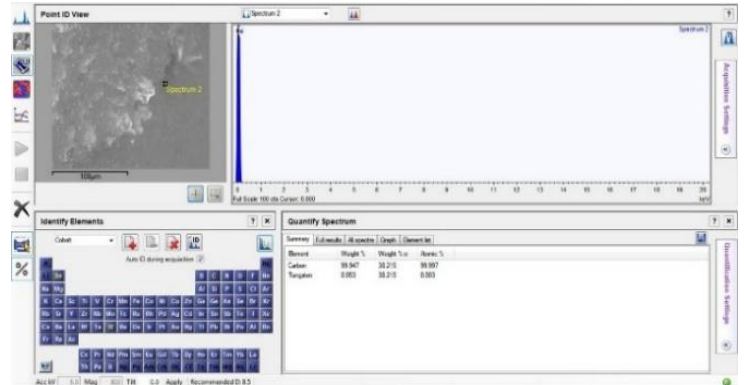
Analysis of the diamond film coating on the cutting tool was carried out during Al-6061 machining at a cutting speed of 385 m/min within the initial wear stage (t<sub>c</sub> 1.74 min; VB 0.07 mm). The obtained results are summarized in Table 12 and presented in Figs. 18 and 19.

Fig. 18. EDS elemental spectrum [1] of the diamond film coating during the machining of Al-6061 at a cutting speed of 385 m/min

Fig. 19. EDS elemental spectrum [2] of the diamond film coating during machining of Al-6061 at a cutting speed of 385 m/min

Chemical interaction analysis using EDS was conducted to evaluate coating integrity and potential interfacial degradation. During the machining of Al-6061 at a cutting speed of 385 m/min, the EDS results presented in Table 12 showed carbon concentrations exceeding 99% in both spectrum [1] and spectrum [2]. These values indicate that the diamond film coating remained intact throughout

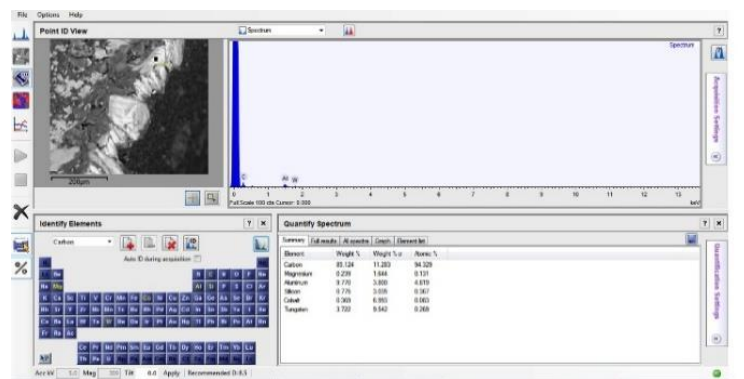
Subsequently, machining tests were conducted at a cutting speed of 462 m/min. During the initial wear stage (t<sub>c</sub> 1.74 min, the measured flank wear (VB) was 0.1 mm in the machining of Al-6061. The corresponding results are presented in Table 13 and illustrated in Figs. 20 and 21.

Fig. 20. EDS elemental spectrum [1] obtained during the machining of Al-6061 under the cutting speed 462 m/min

Fig. 21. EDS elemental spectrum [2] obtained during the machining of Al-6061 under the cutting speed of 462 m/min

the analyzed regions. In the area subjected to abrasive wear, the coating effectively protected the WC/Co substrate and showed no evidence of degradation or chemical modification from external factors. At a 20% increase in cutting speed to 462 m/min, the results presented in Table 13 showed carbon concentrations exceeding 94% in both spectrum [1] and spectrum [2], confirming that no coating delamination occurred. Further elemental analysis detected the presence of aluminium, magnesium, and silicon, in addition to carbon and the constituent elements of the WC/Co substrate. These elements originated from the workpiece material and were likely diffused into the coating region as a result of the increased cutting speed accompanied by a rise in cutting temperature. Nevertheless, the high carbon content detected in both spectra indicates that the diamond film coating maintained good chemical stability and experienced only minimal chemical degradation throughout the machining process. Furthermore, the analyzed regions exhibited a fully preserved coating structure with no evidence of interfacial failure under the investigated cutting-speed conditions. The absence of coating delamination indicates that the diamond film-coated carbide tool maintained its structural integrity throughout the entire range of cutting speeds evaluated in this study. This behavior differs from the findings reported in [10], which identified increasing cutting speed as a primary factor promoting coating failure in coated carbide tools. This discrepancy suggests that the susceptibility of a coating to delamination under high cutting speed conditions is strongly influenced by the characteristics of the coating, the properties of the workpiece material, and the machining conditions employed.

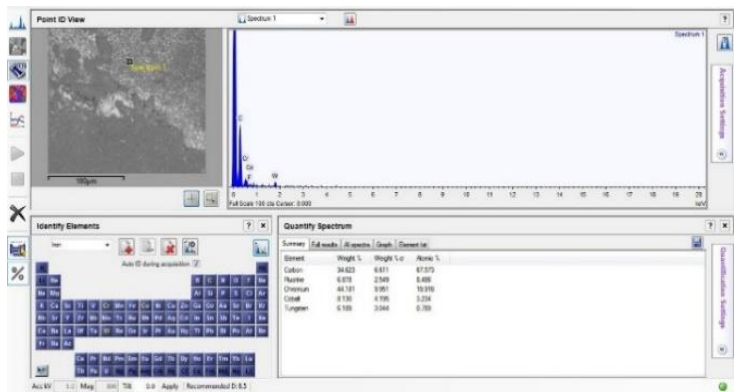
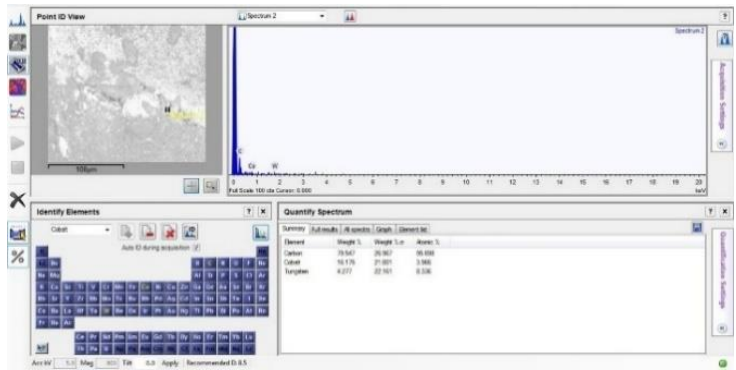
Analysis of the diamond film layer on the cutting tool was conducted during the machining of AISI 1070 at a cutting speed of 111 m/min. During the initial wear stage (tc) 1.1 min, the measured flank wear reached (VB) 0.25 mm. The experimental data are summarized in Table 14 and presented in Figs. 22 and 23.

Fig. 22. EDS elemental spectrum [1] obtained during the machining of AISI 1070 at a cutting speed of 111 m/min

Fig. 23. EDS elemental spectrum [2] obtained during the machining of AISI 1070 at a cutting speed of 111 m/min

The machining of AISI 1070 resulted in localized elemental redistribution within the analyzed wear region. As presented in Table 14, at a cutting speed of 111 m/min, the carbon concentration, which represents the principal constituent of the diamond film coating, decreased to 67.573% in spectrum [1]. This reduction was accompanied by the detection of Cr, Co, and W, indicating localized thinning of the coating layer and partial exposure of the underlying tool substrate. The presence of these elements, originating from both the WC/Co substrate and the workpiece material, suggests the occurrence of material transfer and diffusion within the tool-workpiece contact zone. The reduction in carbon concentration, together with the appearance of foreign elements, confirms that progressive abrasive wear had degraded the diamond film coating in this region. This localized degradation is consistent with the high mechanical loading experienced during the initial wear stage (tc) 1.1 min, where elevated contact stresses promoted coating damage within the critical tool-workpiece interface. Although the diamond film coating possesses exceptional hardness, its inherent brittleness may increase its susceptibility to localized fracture and subsequent abrasive removal under severe loading conditions. In contrast, spectrum [2] exhibited a carbon concentration of 95.698%, indicating that the coating remained largely intact in this region. This observation suggests that coating degradation was not uniformly distributed across the tool surface but was concentrated in localized high-stress contact areas, while other regions maintained good coating integrity. The results further suggest that excessive contact pressure may inhibit the formation of protective deposits at the cutting edge, whereas appropriate contact conditions are required to promote the development of stable protective layers during turning operations. Therefore, optimization of tool-workpiece contact conditions is essential for enhancing the protective capability and wear resistance of diamond film-coated carbide tools during the machining of AISI 1070. The present results corroborate the findings reported by [8], indicating that mechanical fracture is the dominant wear mechanism controlling tool degradation. Moreover, carbon diffusion from the WC substrate and the Co binder contributed significantly to the acceleration of wear progression during the machining of Ti6Al4V titanium alloy.
