## Analysis Of Helical Gear Failure In Off-Road 4×4 Gearbox

### Abstract

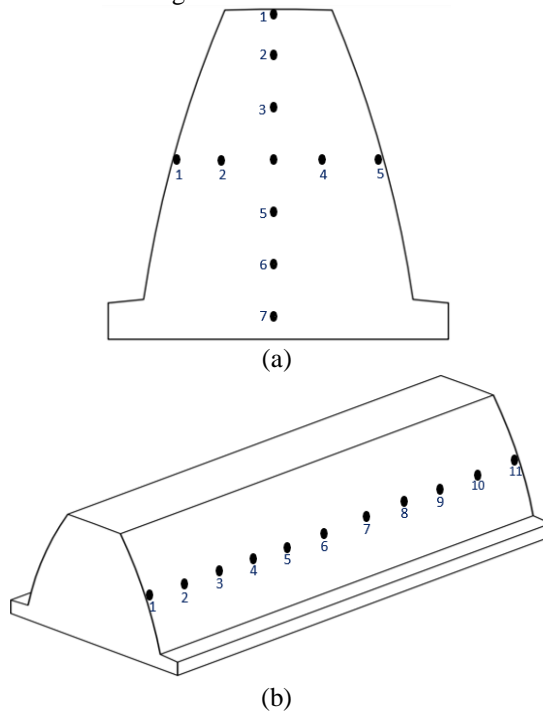
Initiated by cutting a sample close to the fracture surface on the helical gear, hardness testing points were shown in Fig. 2. The sample was then ground to achieve a flat surface, with testing conducted on both outer and inner surfaces to ascertain uniform hardness. Rockwell hardness testing, following ASTM E18 standards, used a Zwick/Roell ZHV 10-type tool.

Fig. 2. Hardness testing points, (a) center part, (b) side part.

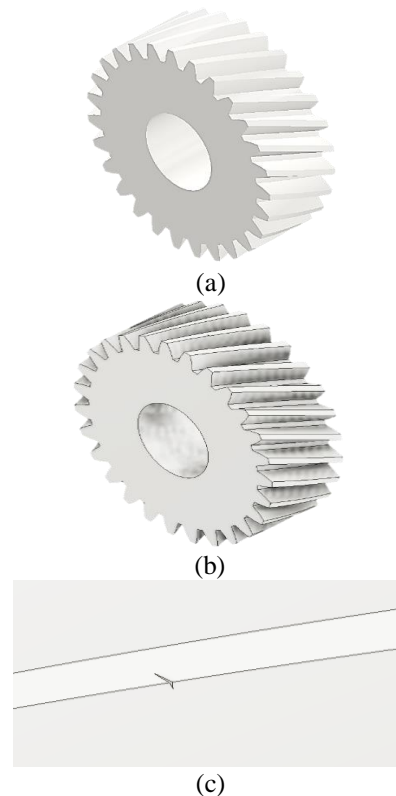
Gear geometry modeling in Autodesk Inventor software consisted of two types, namely a flawless model and a model with initial crack shown in Fig. 3.

Fig. 3. (a) Model without crack, (b) model with initial crack, (c) enlarged defect area.

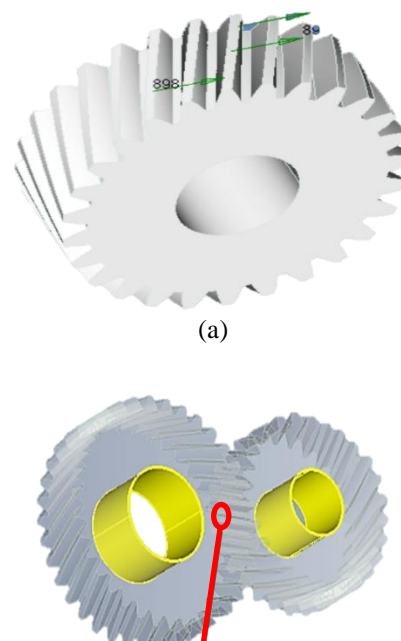
The preprocessing comprised two stages, and the first comprised inputting material properties for AISI 1080. In the second stage, a load of 898 N, derived from gear force calculations, was applied. Boundary conditions were determined, as shown in Fig. 4.

Fig. 4. (a) Load application location and (b) boundary condition determination location.

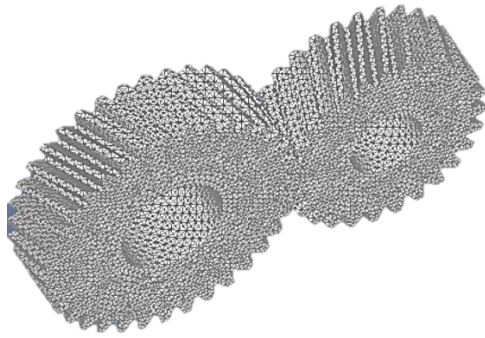
Meshing divided a 3D model into discrete domains, significantly influencing simulation accuracy. Smaller mesh settings produced simulation results closer to actual values. Meshing, shown in Fig. 5, subdivided gear model into smaller elements.

Fig. 5. Meshing results on gear.
