Detection and root cause analysis of minor tread defects in tire manufacturing using optical laser profilometry and fault tree analysis

Arwan Suwandoyo, Daisman Purnomo Bayyu Aji*

Department of Mechanical Engineering, University of Trisakti,
Jakarta 11440, Indonesia

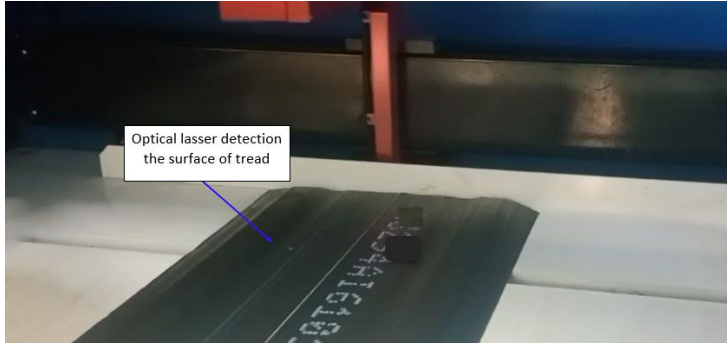
Fig. 6. Optical laser profilometer scanning process on the tread.

The tread scanning process using an optical laser profilometer is presented in Fig. 6. The workpiece was placed on the scanning worktable, and the operator selected the appropriate tread type for surface measurement within the profilometer system. The measurement procedure was initiated via the system interface, enabling automatic scanning.

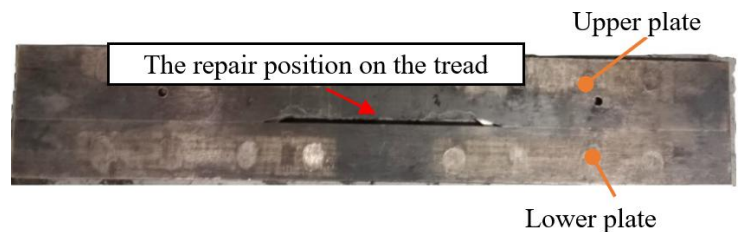
Fig. 9. Front view of die tread.

Fig. 9 and Fig. 10 illustrate the structural configuration of the tread die used in the tread extrusion process. The tread die assembly consists of three primary components: the upper plate, lower plate, and second plate, each of which plays a specific role in controlling compound flow and shaping the tread profile during extrusion.

Therefore, corrective action was required on the tread die (mold) by increasing its thickness or material volume through controlled material removal (grinding/filing), as shown in Fig. 9.

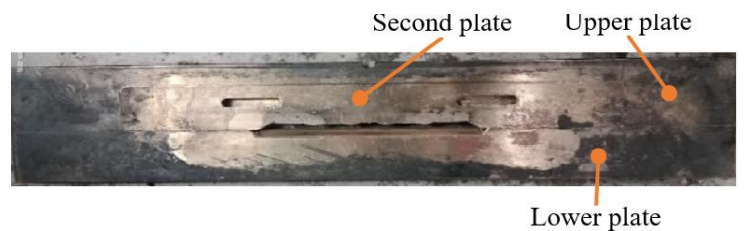
Fig. 10. Rear view of the tread.

The upper plate serves as the outlet channel for the rubber compound that forms the upper section of the cap tread. This component directly influences the dimensional stability and surface profile of the upper tread layer during extrusion. The lower plate serves as the outlet for the compound forming the lower portion of the tread structure. It is mechanically connected to the performer, which acts as the feeder supplying the lower compound stream into the die system. Meanwhile, the second plate is connected to the compound inputs associated with the wing tape tread and the center tread (cap tread). This component plays a crucial role in regulating compound distribution, shaping tread geometry, and directing compound flow forward during the tread-forming stage.

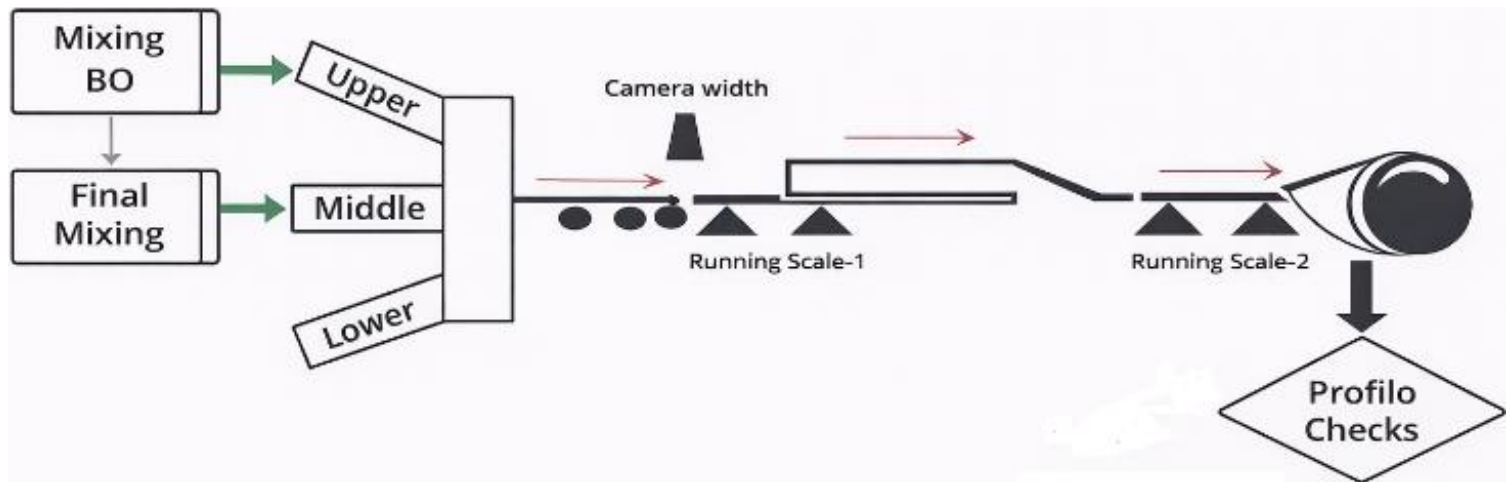
Fig. 12. Schematic of the tread material manufacturing process.

The compound entering through the upper channel forms the wing tape tread, which is located on the outer side of the tread profile. The compound supplied through the middle channel forms the cap tread, which serves as the tire's main contact surface with the road. Meanwhile, the compound delivered through the lower channel forms the under tread layer, which functions as the supporting structure beneath the cap tread and contributes to bonding and structural stability.

Fig. 12 illustrates the process flow of tread material production in the tread extrusion line. In this process, rubber compounds are fed into the extrusion system through three separate channels: the upper, middle, and lower sections. Each channel supplies a specific compound layer that contributes to the final tread structure.
