Analysis of Quenching Temperature Variations in the Heat Straightening Process for Multiple Repair FCAW Welding HSLA SM490YA Material

Mohammad Thoriq Wahyudi*, Moh Syaiful Amri, Muhamad Ari, Mukhlis, Fais Hamzah, Azriel Harsha Novaldi

Department of Welding Engineering, Shipbuilding Institute of Polytechnic Surabaya, Surabaya, 60111, Indonesia

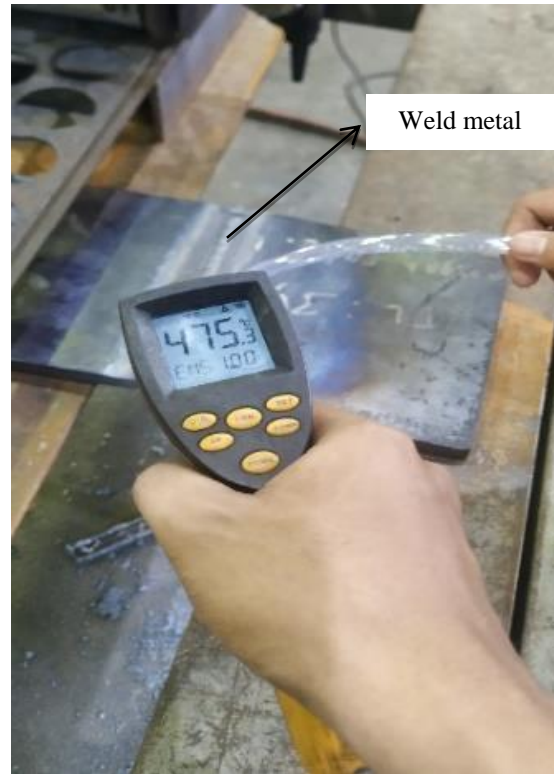
Fig. 3. Quenching Process

heating process. Note the time obtained from the heat-straightening process. The heat straightening process was carried out using a heating scheme for the number of specimens of six joints: 3 joint specimens are repaired twice with a heating temperature of 650°C and watercooling media, and 3 joint specimens are repaired three times with a heating temperature of 650°C and water cooling media. After the heat straightening process is carried out, the quenching process continues. The quenching process is carried out on areas exposed to heat after heating the material using water from a hose.

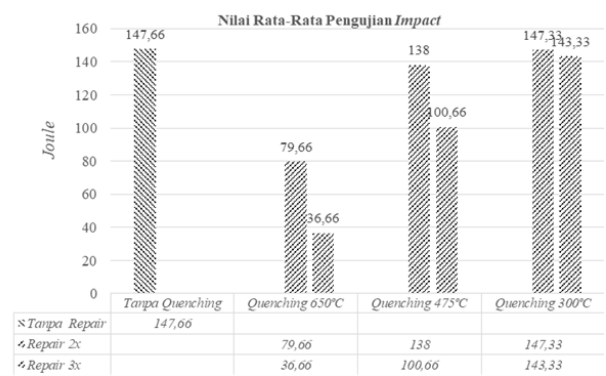
Fig. 5. Average value of impact testing

specimens. The energy results (joules) obtained from the impact tests that have been carried out can be seen in Fig. 5.

From the results of the impact tests that have been carried out, the impact energy value decreases as the welding repair process and quenching temperature increase. The number of repairs will influence a significant reduction in energy absorption in impact testing [4]. Apart from that, the heat straightening process in the deformation area and then cooling quickly to the temperature after the heat straightening process also results in a decrease in the impact energy value.

For example, in the impact value of the HAZ(Heat Affected Zone), the highest impact energy value is found in the 2x repair specimen with a quenching temperature of 300°C, namely 147 joules, while the lowest impact energy value is in the 3x repair specimen with a quenching temperature of 650°C, namely 36 joules. So the 3x welding repair with quenching treatment at a temperature of 650°C is not recommended because it does not meet the acceptance criteria for the impact test energy value at a temperature of 0°C according to AWS D1.1:2020, namely 54 Joules[1]. But if you refer to the JIS g3106 material standard which states that the impact energy value at a temperature of 0°C is a minimum of 27 joules[7]. so the value of 36 joules is still considered acceptable.
