Scientific literature reviews; investigating analysis of turbine blade operational failure

Riki Effendi* and Franka Hendra

¹Departement of Mechanical Engineering, University of Muhammadiyah Jakarta, Jakarta, 10510, Indonesia

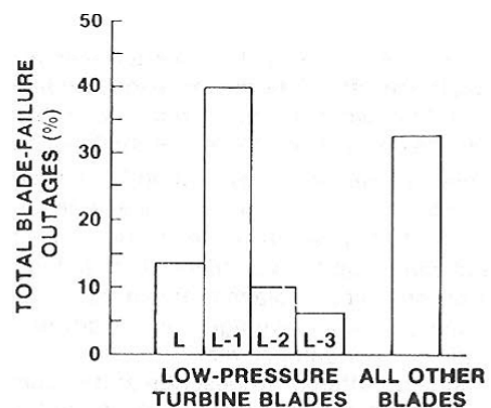
Fig. 1. Distribution of blade failures in fossil turbines in the USA [11].

Low-pressure steam turbine blades, as shown in Fig. 1, are more prone to failure than medium and high-pressure steam turbine blades. Corrosion Fatigue (CF), Stress Corrosion Cracking (SCC), pitting corrosion, and erosive corrosion are the most common mechanisms of failure of low-pressure blades in steam turbines [9]. Hata et al [10] came to the conclusion that corrosion fatigue is the primary mechanism of low-pressure steam turbine damage and that any fatigue cracking should be regarded as corrosion fatigue. Corrosion-chemical enrichment is thought to be closely related to corrosion-fatigue damage to the blade in wet/dry transition zones and aggressive environments. Many researchers have confirmed that corrosion-fatigue cracks frequently form from holes in intercrystalline cracks and progress as flat fatigue cracks with coastal markings and strokes, as revealed by fractography [11].

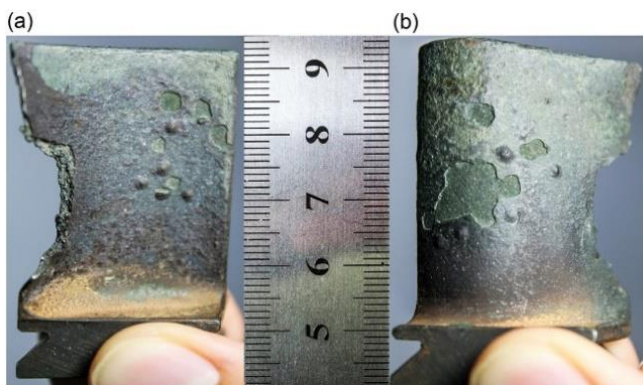
Fig. 2. First-stage-nozzle blade of gas turbine a) pressure surface, b) suction surface [13].

According to [13] structural analysis (XRD) corrosion products on the blade shows that the most significant amount of deposit is formed from NiO and Cr₂O₃ as shown in Fig. 2.

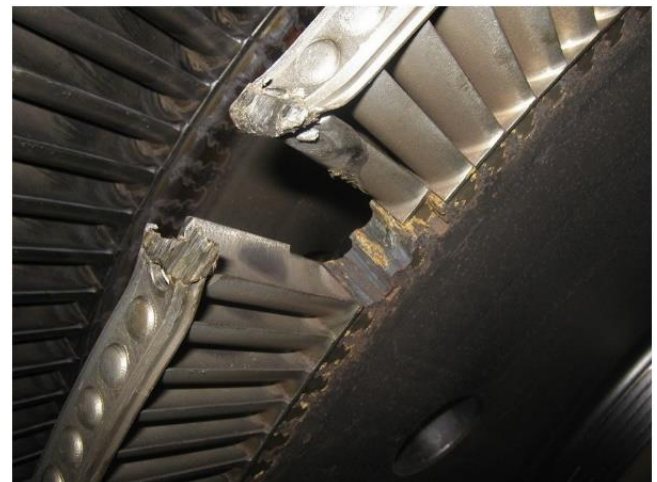
Fig. 3. Fracture surface of the rotor blade roots-5th rotor wheel [21].

Katinic's [21] research indicates that this is a fracture of two nearby blades. It was discovered that these were the two end blades of a package next to it. The blade root, which is under the most stress, is where the fracture develops as shown in Fig. 3.

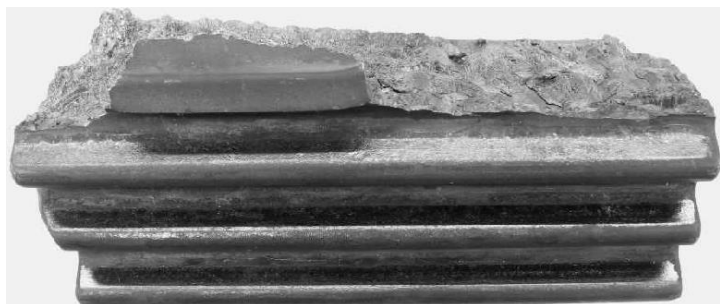
Fig. 4. The area of the spruce root left over from the cracked blades [31].

As shown in Fig. 4, one of the most common areas of fretting failure is the attachment of the blade to the disk at the spruce joint. In gas turbine engines, this is one of the critical components that can fail due to fretting fatigue [30]. Despite the fact that these connections are nominally fixed, there is relative movement in the microscale at the interface between the contacting bodies as a result of centrifugal tangential movements, vibrations, and vibrations, which causes damage and a significant decrease in fatigue life. This is known as fretting fatigue, and it frequently occurs at the attachment points of gas turbine and jet engine blades and disks [31].
